# QUICK RECOVERY OF THE KEK E-/E+ INJECTOR LINAC FROM THE GREAT EAST JAPAN EARTHQUAKE

Atsushi Enomoto, -KEK, Tsukuba, Japan

## Abstract

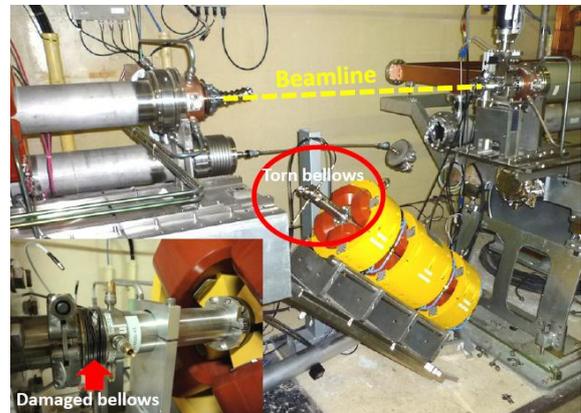
The peak earthquake strength was 6-lower in the Japanese scale which has been never experienced so far, and strong oscillation lasted nearly five minutes. The acceleration of the ground motion was recorded 0.3 – 0.4g in Tsukuba. Just after the quake went away a visual investigation was initiated in the darkness without electricity. And it was immediately turned out the linac was caused heavy damages: In the accelerator tunnel there were many vacuum bellows torn hardly, broken girders, a quadrupole magnet dropped down to the floor

(Fig.1), inflow water coming from the tunnel joints and spilled over the floor, etc.

Figure 1: The linac damage in accelerator tunnel.

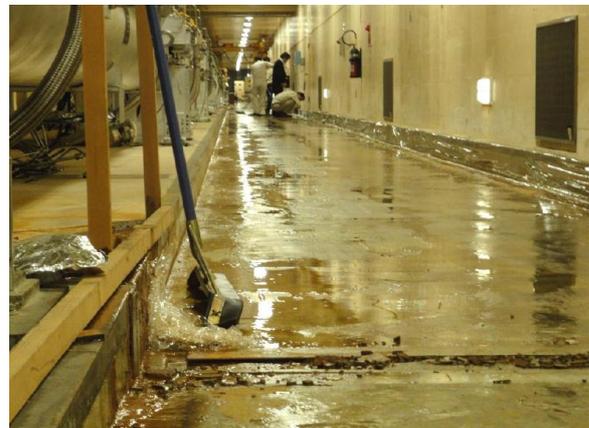
Figure 2: Inflow water into the tunnel.

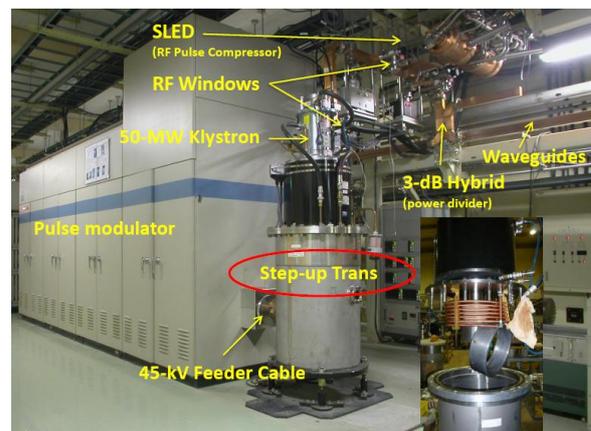
Figure 3: The linac damage in klystron gallery.

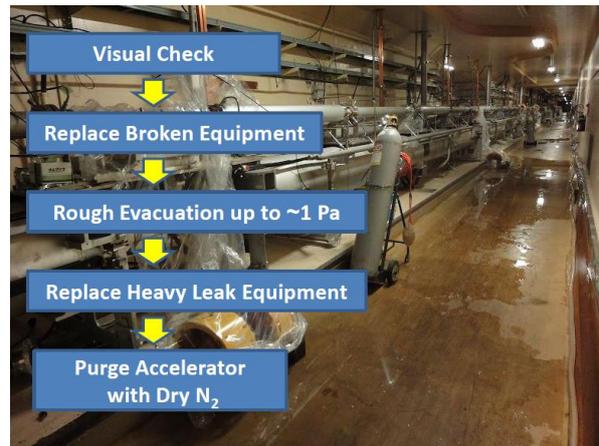
Figure 5: The linac vacuum purge with dry nitrogen.

- (1) The first action was, for all of the accelerator guides, to make “nitrogen purge” (to purge wet atmosphere inside accelerator by dry nitrogen).
- (2) Recovery of the downstream part was prioritized in order to quickly resume the PF and PF-AR injection.
- (3) The remaining part of the linac (the upstream 5 sectors) is then recovered for the SuperKEKB injector by the end of FY 2014.

“Nitrogen replacement” takes the process as follows: After the broken components are replaced, the accelerator is roughly evacuated. When the vacuum pressure can reach ~1 Pa, then it is purged with dry nitrogen (~0.1 MPa = ~1 atom). Though the linac recovery was prioritized over the other facilities at KEK, it was initiated under the limited condition of infrastructures, such as electricity, compressed air, and cooling water. Nevertheless, it was done within two weeks, since this task was addressed by a support from outside of injector vacuum groups.

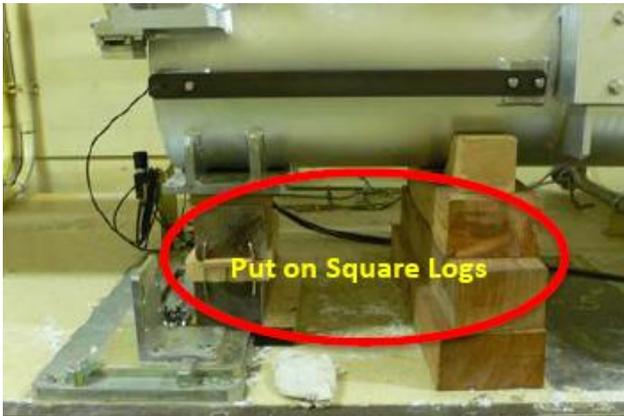
The upstream recovery necessary for the SuperKEKB upgrade was started on July 2011 and is still continuing while operating PF injections. For this purpose, it is really helpful that the upstream part had been separated by thick concrete wall in FY 2010. In the upstream part, many accelerator girders are put on square logs because their support legs are left broken. The beamline among them are not repaired. Therefore, the vacuum recovery of the upstream 40 accelerator units were made by isolating them from the beamline. Thus the accelerator vacuum was finally recovered by the end of November. A high-power test was finished by mid December and it turned out that the accelerator did not have a severe damage. It is planned the entire beamline will be restored before FY2014 when the linac commissioning for SuperKEKB start.

Figure 7: Broken girders are put on square logs.

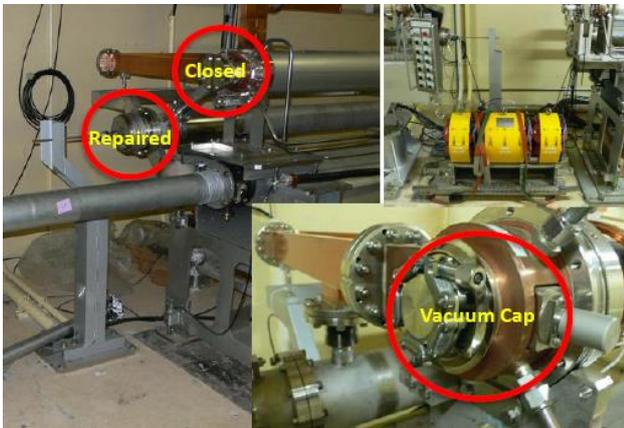
Figure 8: Beamlines are not yet connected (upstream).
