SPRING-8 蓄積リング架台変形の原因と床の長期変動 MAJOR CAUSES OF GIRDER DEFORMATION OF SPRING-8 STORAGE RING AND LONG-TERM VARIATION OF TUNNEL FLOOR

C. Zhang^{A)}, M. Hasagawa^{B)}, T. Shinomoto^{B)}, H. Yamamoto^{B)}

^{A)} Japan Synchrotron Radiation Research Institute

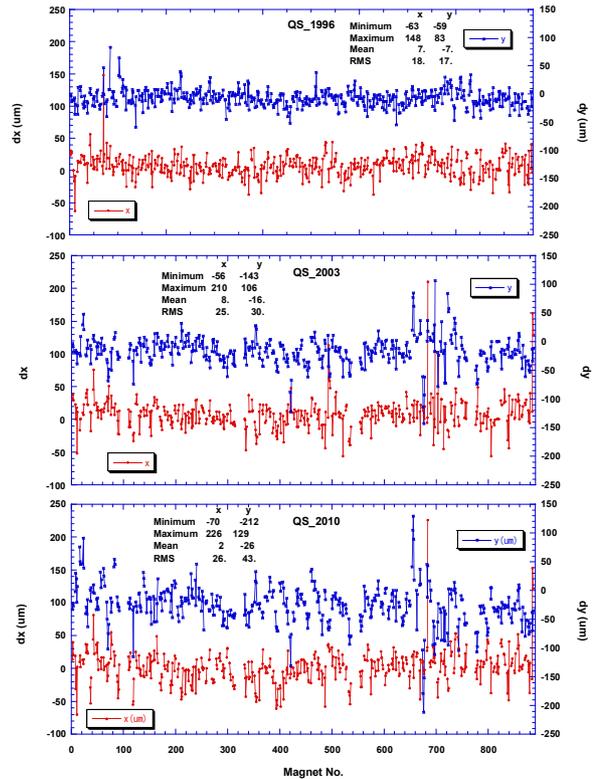
Linearity of magnets within girder was measured 3 times in 1996, 2003 and 2009 respectively. It was found that the RMS displacements varied $7\mu\text{m}$ in horizontal and $13\mu\text{m}$ in vertical from 1996 to 2003, while there was almost no change during 2003 - 2009 in horizontal. On the contrary the vertical makes a constant deterioration of $\sim 2\mu\text{m}$ per year (figure 2).

Figure 2: Linearity errors of magnets within girders measured in 1996, 2003 and 2009, with the laser alignment system of CCD-camera.

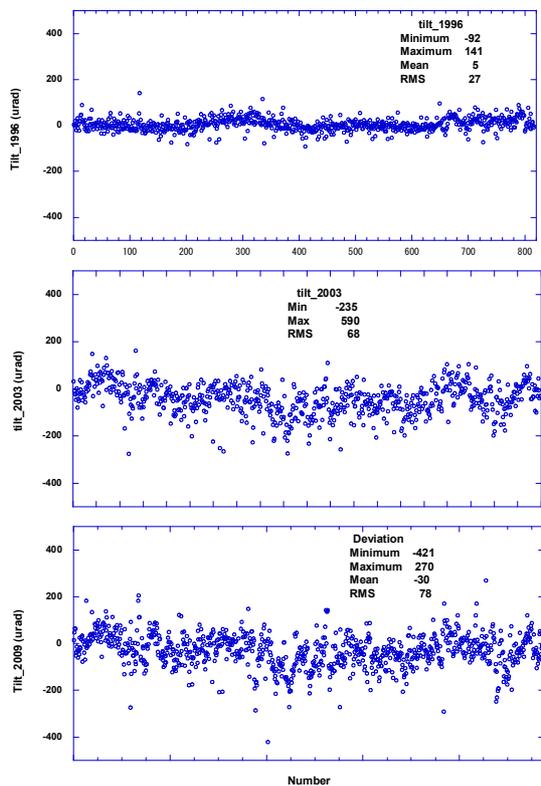
The rolling of magnets on the girder was also measured three times in 1996, 2003 and 2009. The results show the same trend. From 1996 to 2007, RMS tilt changed from $27\mu\text{rad}$ to $68\mu\text{rad}$ in seven years. However there was almost no change in the following 6 years, from 2003 to 2009 (fig.3).

Both the displacements and the tilts of the magnets illustrate that the position variations of the magnets on the girders is occurred merely in vertical plane since 2003.

Figure 3: Tilt of rolling of the magnets on girders, measured in 1996, 2003 and 2009 respectively with the leveler of Talyvel.

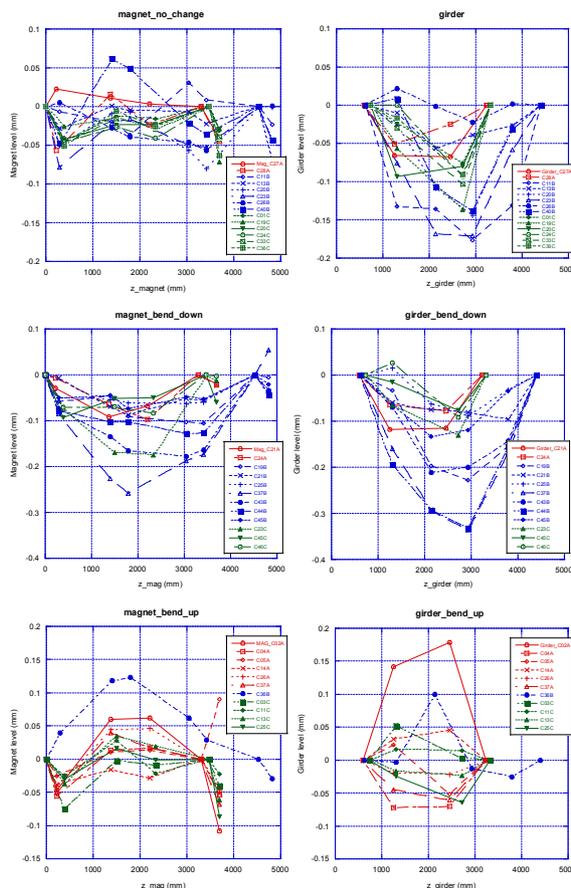
37 girders were measured around the ring, because of other having large variations or having no changes. The results are plotted in three groups as shown in figure 5, according to the directions of magnet displacements: bent up, bent down or no change.

Figure 5: The shapes of girders (right) are grouped into 3 according to the directions of magnet displacements, bent up, down or no change (left). And, for the colours, red: girder A; blue: girder B; green: girder C.

The results show the girders were bent in the middle. And, the followings are made clear.

- The girders of which the magnet's linearity had no change sunk about 0.05mm in the middle of girders A and C, and 0.1~0.15mm for girder B.
- The girders of which the magnets bent down had sunk about 0.1mm for girders A and C, and about 0.1~0.3mm for girder B. And, most of B-girders bent down except one.
- The surfaces of the girders which the magnet went up were flat, or bent upward. That occurred almost at A or C-girders.

It is evident that before we did the precise alignment of magnets, the bent of the girders had occurred already. Because the amount of girder sag is larger than that of the magnets.

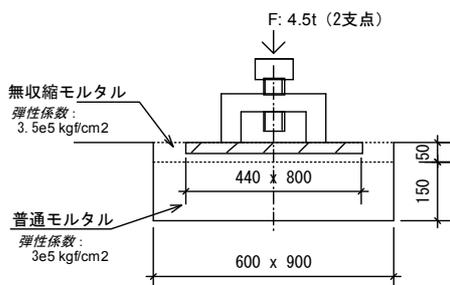
The girders mount footstool on three baseplates of steel which is shown in figure 6. During the installation of the ring, the baseplates were adjusted to same levels and then the mortar of shrink and non-shrink were filled under the plate. After several months dry up of the mortar the girders and magnets were set on the baseplates.

Figure 6: On of the three baseplates of the girders. The steel plates were adjusted to same level and mortar is filled under them.

The reason of girder band before alignment is no clear. Elastic deformation of the steel support and the mortar was about 0.02mm with the conditions shown in the figure, small enough comparing to the amount of the girder bend. It is considered that after the girders and magnets setting on the baseplate, the dry up of the mortar was still in progress, and the middle leg of the girder shrunk more because of larger load. While, it needs further information to make sure of it.

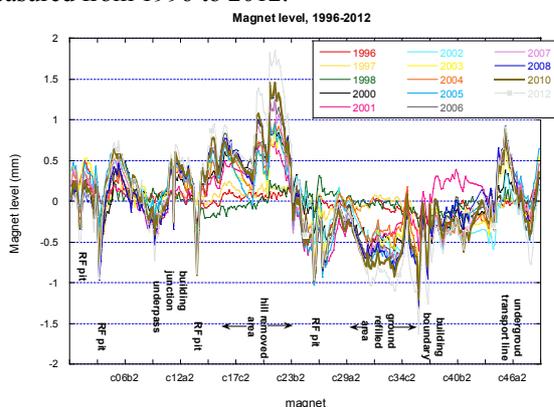
Figure 7 shows the displacement of magnets in level measured from 1996 to 2012.

Figure 7: Displacements of magnets in level measured from 1996 to 2012.

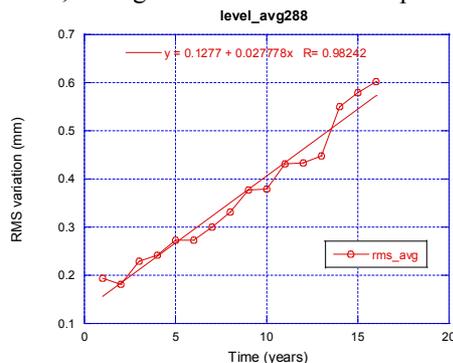
Figure 8 is the correlation of the RMS displacement and time interval, averaged for all measurement points.

Figure 8: Correlation of the RMS displacement and time interval, averaged for all measurement points.

It is estimated that in the vertical, the average RMS displacement varies at a rate of

$$\sigma = 0.028 T \text{ (mm)}$$

RMS displacement varies from 0.2mm to 0.6mm in sixteen years. For the more, the variation is seen no sign to slow down.

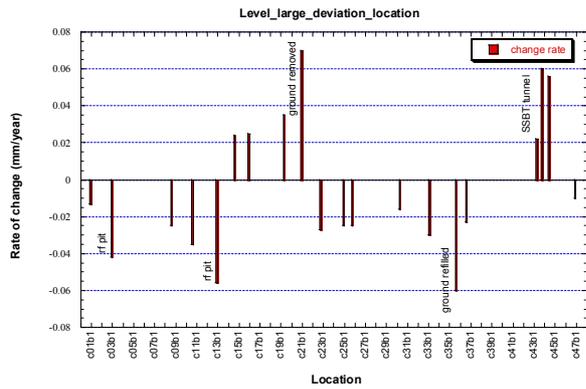
For each point the ground deterioration rate can be calculated. Figure 9 gives the locations that had large movement. At some places of the ring the deterioration are around 0.06mm/year, almost located at the RF pits, tunnel junctions and SSBT etc. where have underground structures. The girders that had large deformations ride just on the places above.

Figure 9: Locations that had large ground movements, some are around 0.06mm/year.

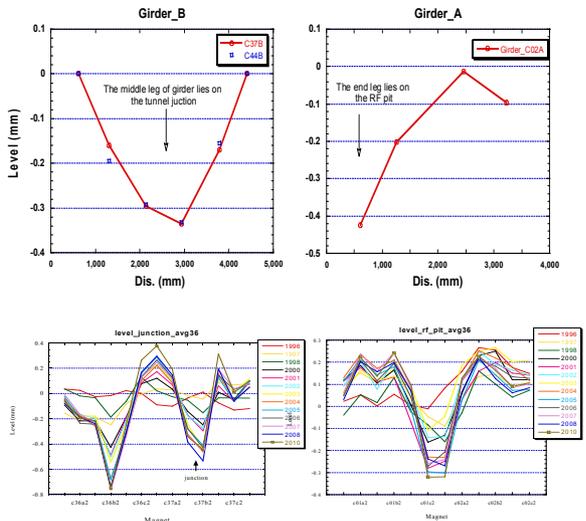
- Both the magnets and the girder of C37B were bent down in the middle for ~0.3mm.
- C02A and C36B bent up in the middle for about 0.15mm.

The shapes of the girders surfaces are plotted in figure 10, when taking count of the levels of tunnel floor.

What had occurred is the one of the three legs of the girder are ride on the ground where had sunk a lot in past years.

Figure 10: Shapes of the girders surfaces (upper) and tunnel floor levels (lower) of the girder C37B and C02A.

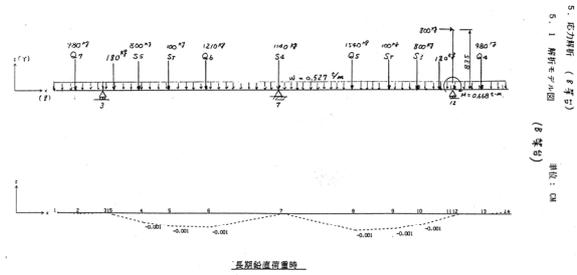
The girders should have had little deformation because the design criterion was 0.02mm for the sag. While, actual bends are 10 times of this value in some girders. Girder design is reconfirmed with the ANSYS. With three legs and load conditions shown in figure 11, it is confirmed that sags for three types of girder are under 0.01mm.

Figure 11: Deformation calculation of the girder with 3 legs. Maximum sag is 0.01mm, for three types of girders.

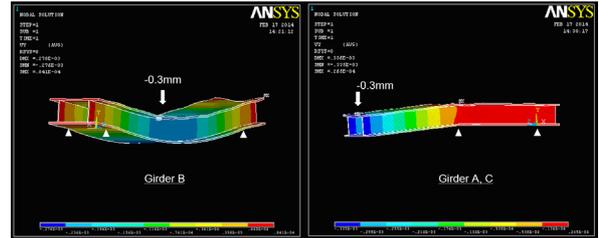
Figure 12: Maximum deformations reach 0.3mm on assumption of the ground settlement large than 0.3mm.

Because of the floor settlement, the supports of 6-point could become 4-point to the extreme and maximum deformation of the girders reaches 0.3mm as shown in figure 12. Actually, the case of C37B mentioned above just verifies the analysis.
