HIGH-POWER TESTS OF REPAIRED CIRCULATOR FOR LIPAc RFQ

K. Hirosawa[†], N. Kubo, A. De Franco, K. Kondo, K. Masuda, A. Kasugai, M. Sugimoto, Quantum National Institutes for Quantum Science and Technology (QST), Aomori, Japan
I. Moya, F. Scantamburlo, Y. Carin, Fusion for Energy (F4E), Garching, Germany
L. González-Gallego Sánchez-Camacho, C. Caballero, J. C. Morales Vega, University of Granada (UGR), Granada, Spain

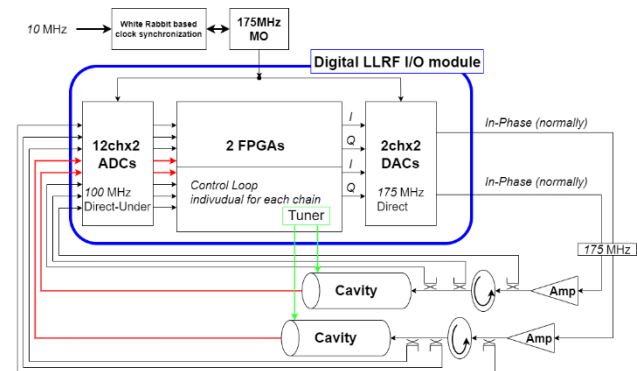
The LIPAc RF system consists of the source and its amplifiers for 1-RFQ, 2-Re-Bunchers, and 8-SRF cavities. The control system is based on one typical design [1], shown in Fig. 1, used in the Re-buncher cavity. In addition to the base model, Master-Slave control loop is implemented but tuner is removed for the RFQ, because the resonance tuning is realized by cooling water loops.

Figure 1: Schematic of the RF control loop.

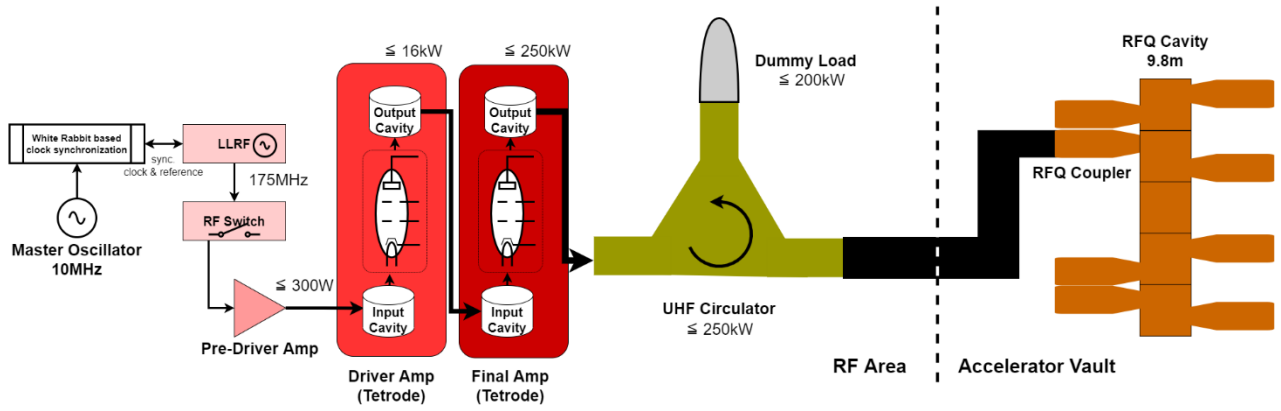
Figure 2: Illustration of 1/8 RFQ-RF amplification system.

The RFQ system of our LIPAc is working as one 9.8 m long resonator. To input 1.2 MW power including beam loading compensation, 8-synchronized RF stations are adapted as shown in Fig. 2 for one station. The reference position of the calibration is just before the RFQ-RF coupler, and RF feed power is tuned to be balanced for RFQ coupling level. This method can work on the assumption of unchanged RF-coupler conditions and the uniformed circulator conditions in any power, phase, and pulse combination. Studies about the condition and the dynamics when above assumption is broken are one of most important point in our having RF system. First point of our starting point related with the RF-coupler issue is discussing in the different report in the meeting. The later topic, the issue of circulator, is dealt with in this report.

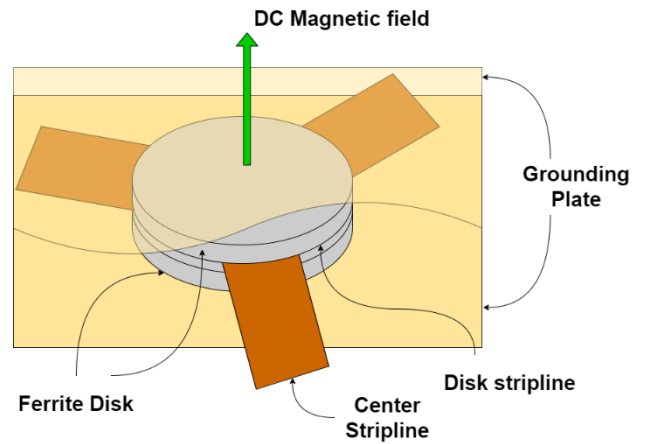
Figure 3: Minimum setup to circulate RF for 3-ports.

The circulator has been studied by the methodological approaches for a long time [6-8]. Figure 3 shows that the minimum setup of the circulator. Most of dynamics of the circulation of electromagnetic waves is determined by the resonance characteristics of the soft ferrite disk, sandwiches the stripline of the large inner conductor plate. Dynamics in the ferrite is represented by the relative permeability [8], written in Eq. (1) and (2). Rectangle brackets is representing matrix form.

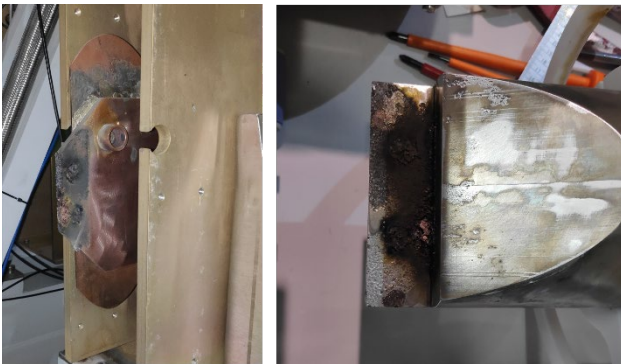
Discharge in the circulator was happened at the port-1 and the port-2. Problem of the port-1 was found in our facility when problem was happened in end of January 2022, the problem in the port-2 was found in the factory of the manufacturer. Figure 4 shows the failure of the port-1 because of bad connection between inner stripline and the transition to the coaxial line. We are guessing that the cause of this failure is thermal cycle of the screws tightened these two components. We don't know it can be deteriorated for a long-term operation or it is initially in the bad state, but the event was happened as the discharge in the small gap. As the temporal solution, we have periodic inspection for all connection parts if they are still well-tightened.

Figure 4: Broken part of the circulator port-1 (2022/Jan).

First action for the repair had been done by polishing the inner stripline and replacing the inner transition to the new one. Inner transition is completely burned and holes for the screw had been melted. The pair part of the stripline had also melted, but it was difficult to replace because one large copper plate is used to the stripline. Our on-site repair result in June 2022 is shown in Fig. 5. Damaged part was polished, but some dips are still existing. Basically, it is not a problem, because dip parts are far from the surface. We

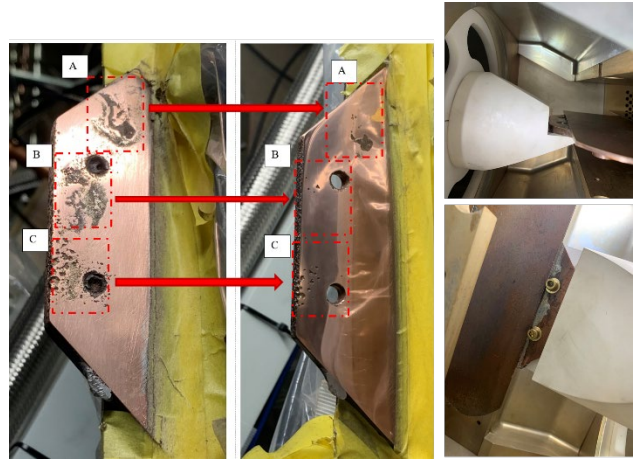
Figure 5: On-site repair for the port-1 (2022/June).

had a 200 kW transmission test after on-site repair, and it was cleared also for the long-term stability check.

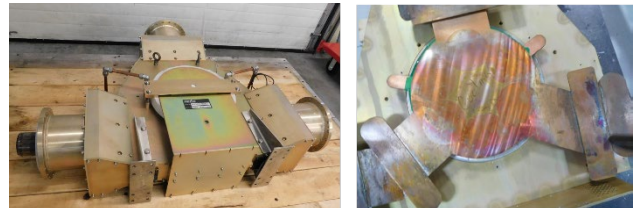
After that, because of manufacturer strong recommendation, we decided to ship it back to the factory in the US, to have an inspection by completely disassembling and reoptimizing the magnetic field of permanent magnets. As shown in Fig. 6, inner stripline was checked and they found spark traces in the port 2. After detailed check for all components, assembly and magnetic tuning was performed. The repair activity in the factory was done from July 2022 to March 2023, and the factory acceptance test was performed in February 2023 shown in Fig. 7.

Figure 6: The circulator and the disassembled stripline.

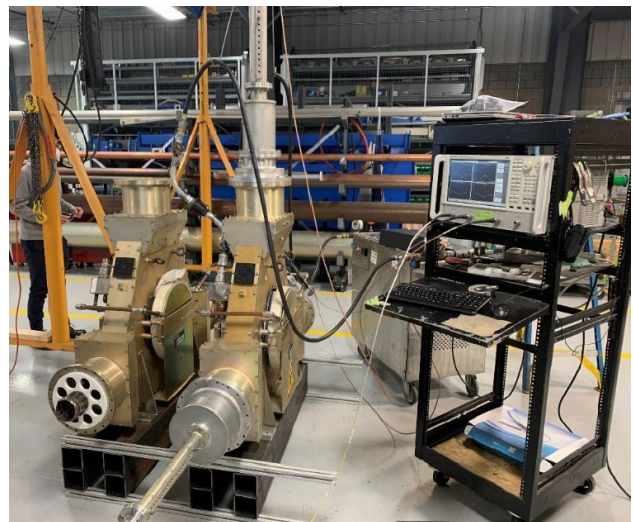
Figure 7: Measurement setup for the factory test.

In the acceptance test, we noticed that the tuning point was changed from 25.5 deg. to 30.0 deg., and the existence of the magnetic materials as the circulator support, but both influences are appeared in the Eq. (4), so we thought it would compensate by the coil current similar as the ohmic loss. In the circulator S-parameters test after delivery, we realized that our understanding in the factory test was not correct.

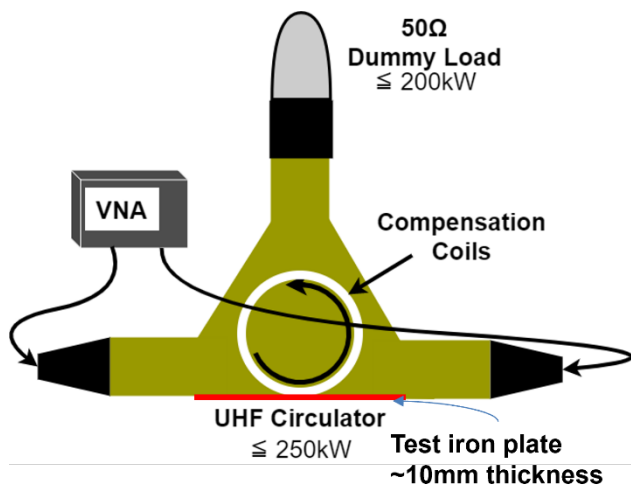
For the repaired circulator, after integration to our RF system, we had a test to characterize the circulator performance by S-parameters. Figure 8 shows the setup of the measurement. To know the effect of near magnetic material, 1cm thickness iron plate was inserted on the bottom of the circulator. First, we measured the resonance point of S-parameters by scanning the coil current. Next, we checked the influence of temperature change and the existence of the iron plate.

Figure 8: Setup of the VNA test for the circulator.

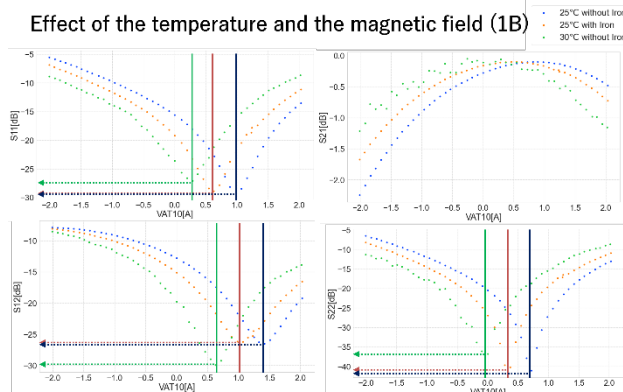
In addition to that, the peak positions in the right-hand side plot looks different. This part is still under study, but related to this point we had a test by changing temperature and existence of the magnetic material. Figure 10 shows the characteristics change for the different temperature and with and without ~1cm thickness iron plate. Blue, orange, and green plots are, respectively, the normal condition, with inserting an iron plate, and temperature change. S_{21} have similar value, but the effect of temperature makes peak level changes. In this case, better directivity but worse return loss was observed. In the Eq. (3) and (4), contributions from temperature appeared in M_0 term and from external field H_0 are not the same. We are guessing that some part of differences is coming from there. From the operation point of view, <math>< 26\text{ dB}</math> stop band shall be no problem.

Figure 10: Illustration of the high-power test setup.

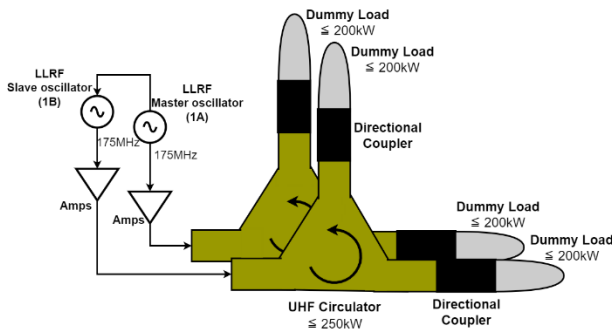
We got good result for both tests without any problem in repaired parts. Especially in the second test, we tested the circulator performance with existence of the pair circulator. The setup was illustrated in Fig. 11. In practical situation, we polarize each circulator in parallel, and so our interesting working point can be confirmed under interactions of the magnetic field including its compensation coil inducing field. As the typical result, the test term for CW-200 kW transmission was shown in Fig. 12. We successfully

Figure 11: Illustration of the high-power test setup.

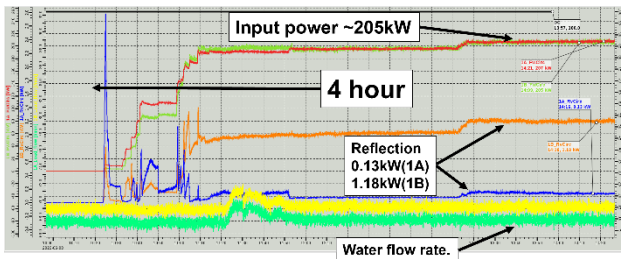
cleared the test for 200 kW in CW operation for a long-term > 3 hours, which is enough to reach steady state.

Figure 12: High-power transmission test of the repaired and its pair circulators for 4-hours in the CW mode.

The return loss of the circulator in the specification sheet checked in the cold test is more than 26dB, but 22.4dB return loss can be seen in the high-power test. The reason of this difference can be imagined because of the thermal effect comes from ohmic loss or the difference of the tuning point. We still don't understand about this part, so we must study it. Though, in any case, stable reflection could be obtained, and the return level is ~1kW in the absolute value, thus it is not a problem for the operation.
