T24 structure fabrication

CASC special meeting on 26.08.2009

G. Riddone, BE/RF

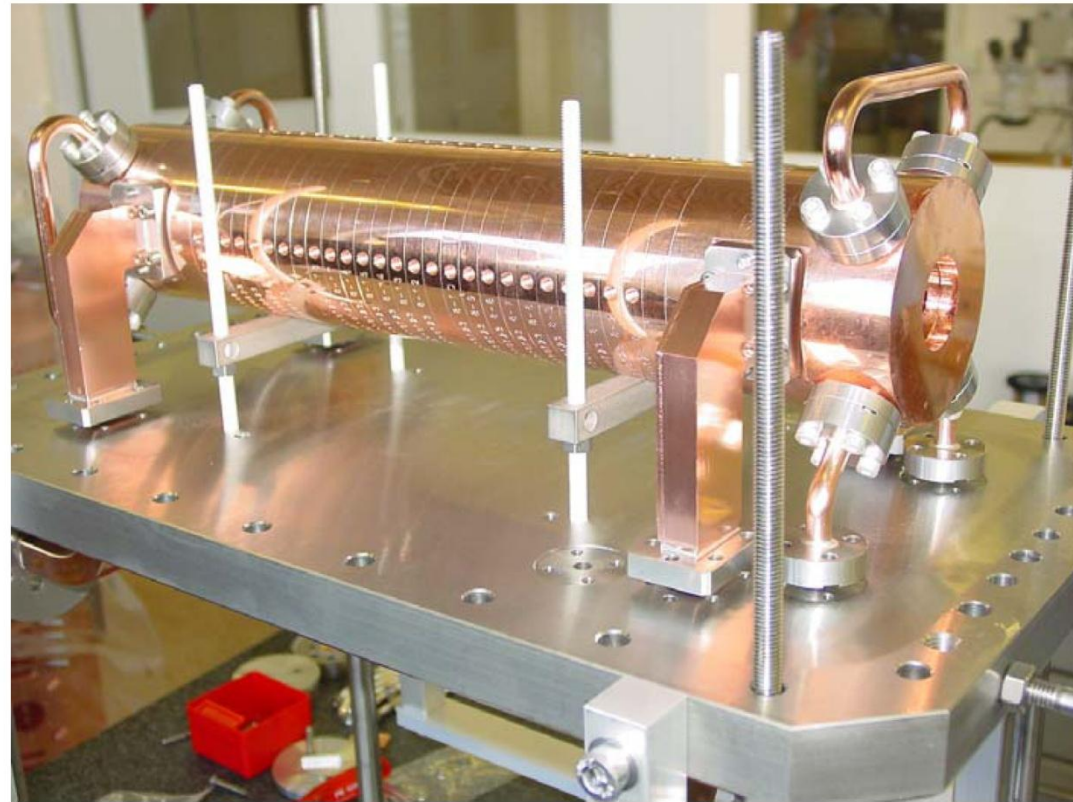
- T24#1:
tank version
- Manufactured
at VDL, Q4 '08
- Assembly at
CERN with “new”
procedure
(following T18
task force) Apr-
Jun 09

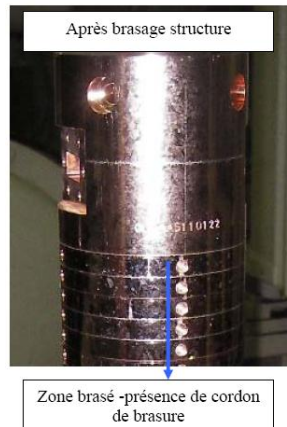
EDMS#10000659

- Pre-fire of disks at 1040 °C
- Brazing of all structure 815 °C, SCP1
- Brazing of cooling circuit 790 °C, eutectic AgCu – **spotsof braze filler material**

EDS analysis of brazing filler metal dropped out - The drops of filler metal in structure 11WNSDvg1.8 have a composition close to the Ag-Cu eutectic with **no evidence of Pd.**

- Traces of braze filler material
 - Compatibility of brazing design (Ag/Cu/Pd ~ 800 C) with pre-fire at 1040 C in Ar (sharp facets observed)
- Oxidation of the structure in clean room
