# Nextef results

CLIC09, Oct. 12-16

T. Higo (KEK)

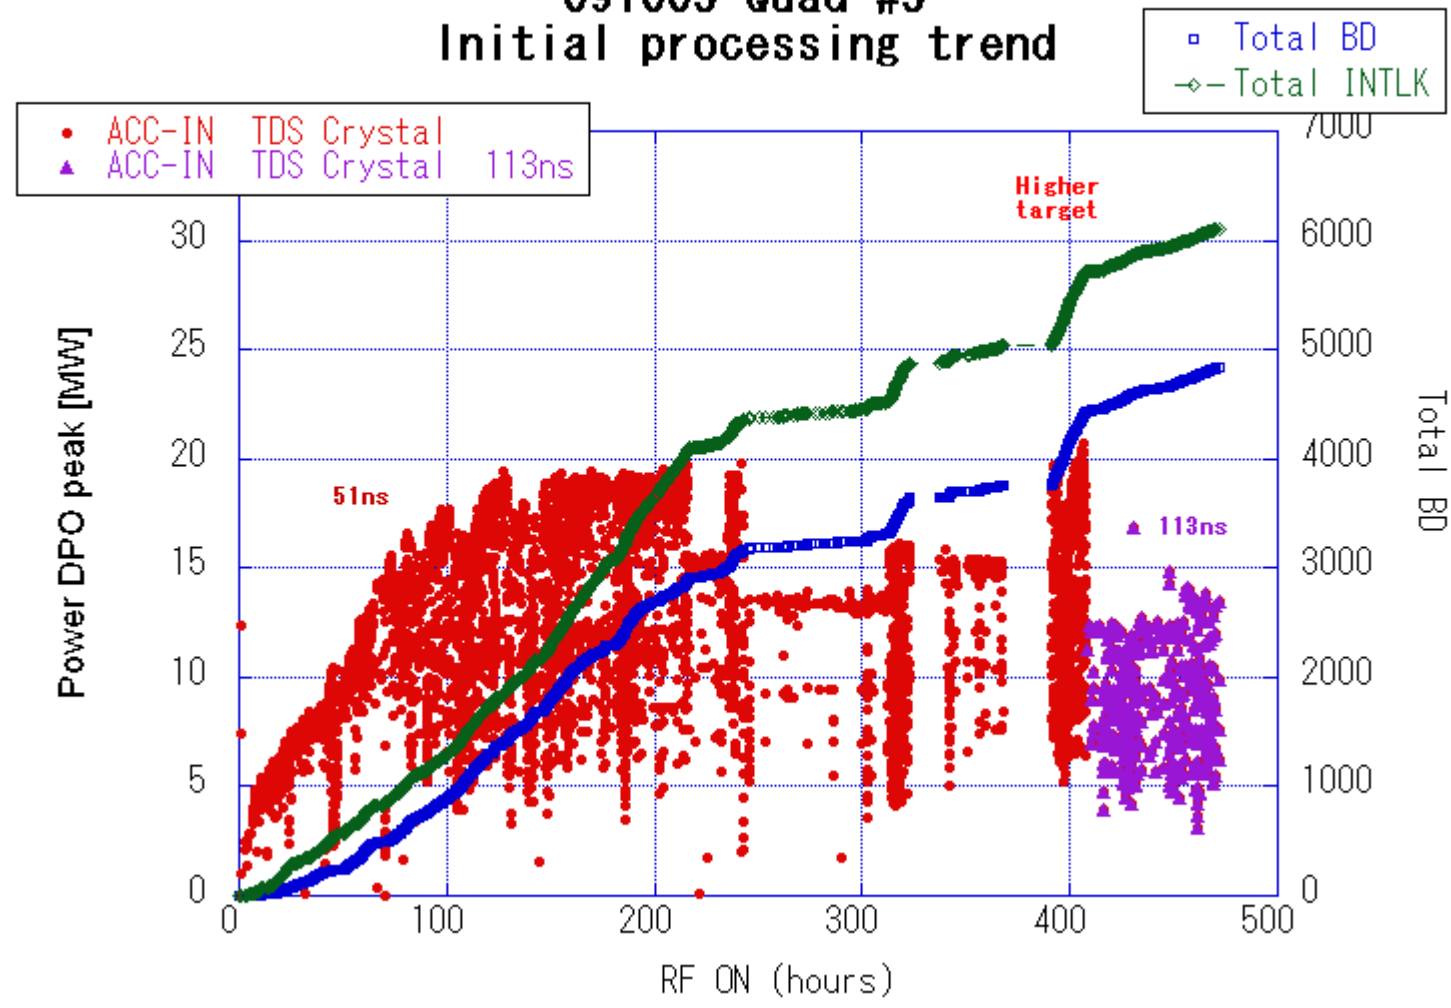
### 091005 Quad #5 Initial processing trend

Red=power (arbitrary unit)

Blue = Chamber vacuum [Pa]

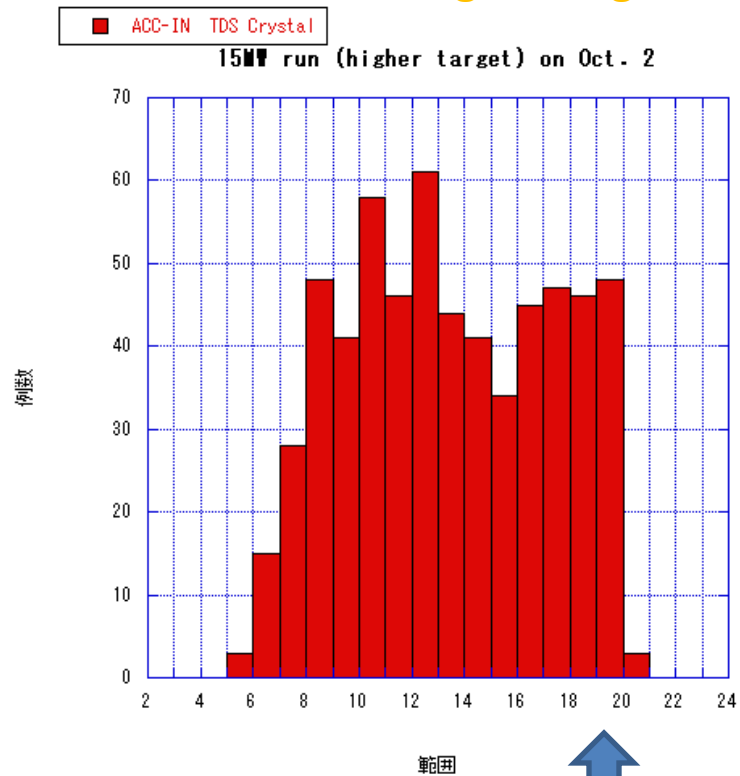
Higher target

Hard limit at 19MW,  
59MV/m, 50ns

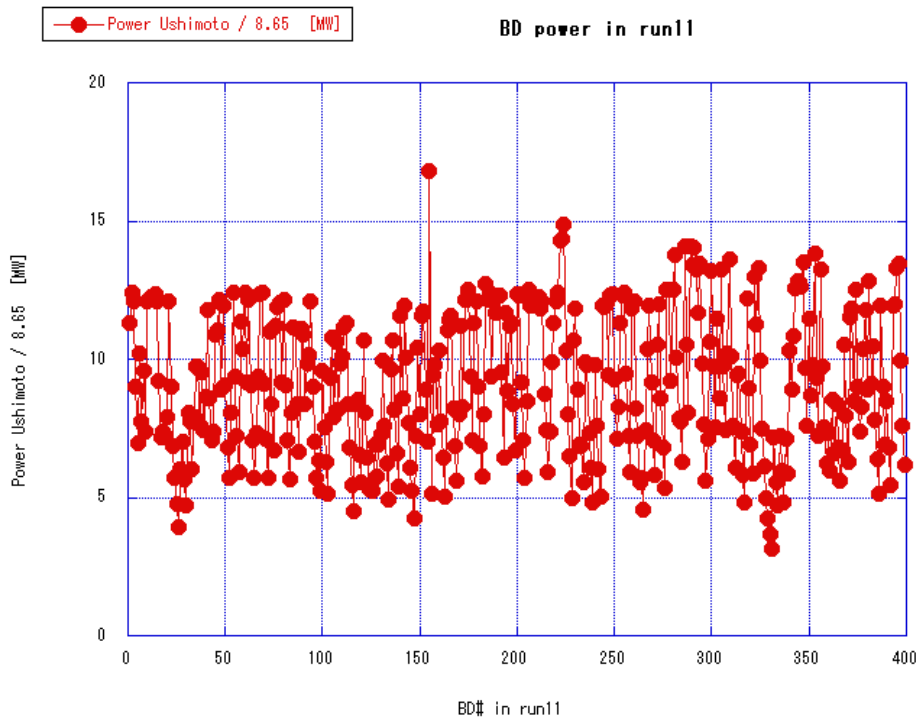
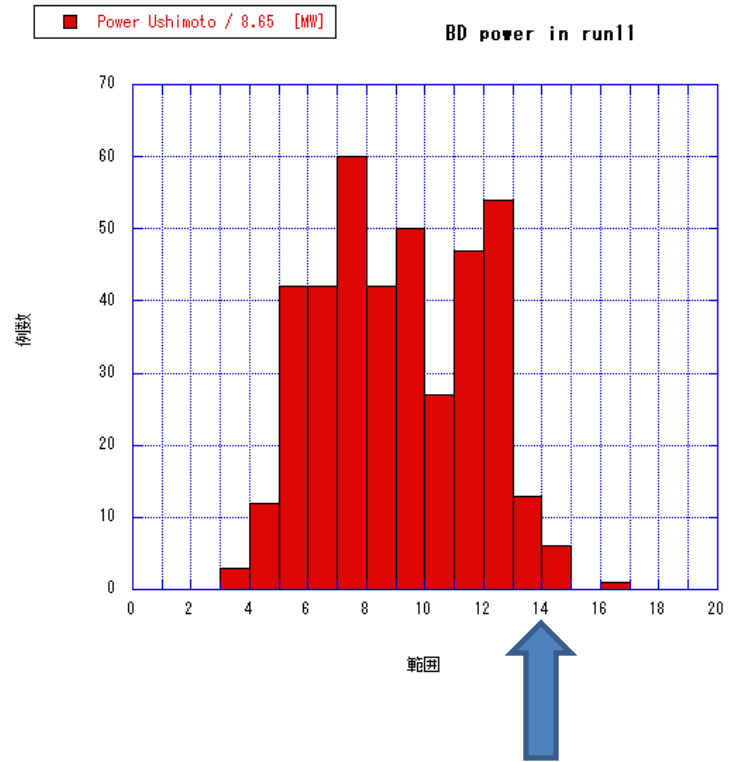
Powers at breakdown with 113ns pulse width for 60 hours

Hard limit at 14MW for 113ns pulse

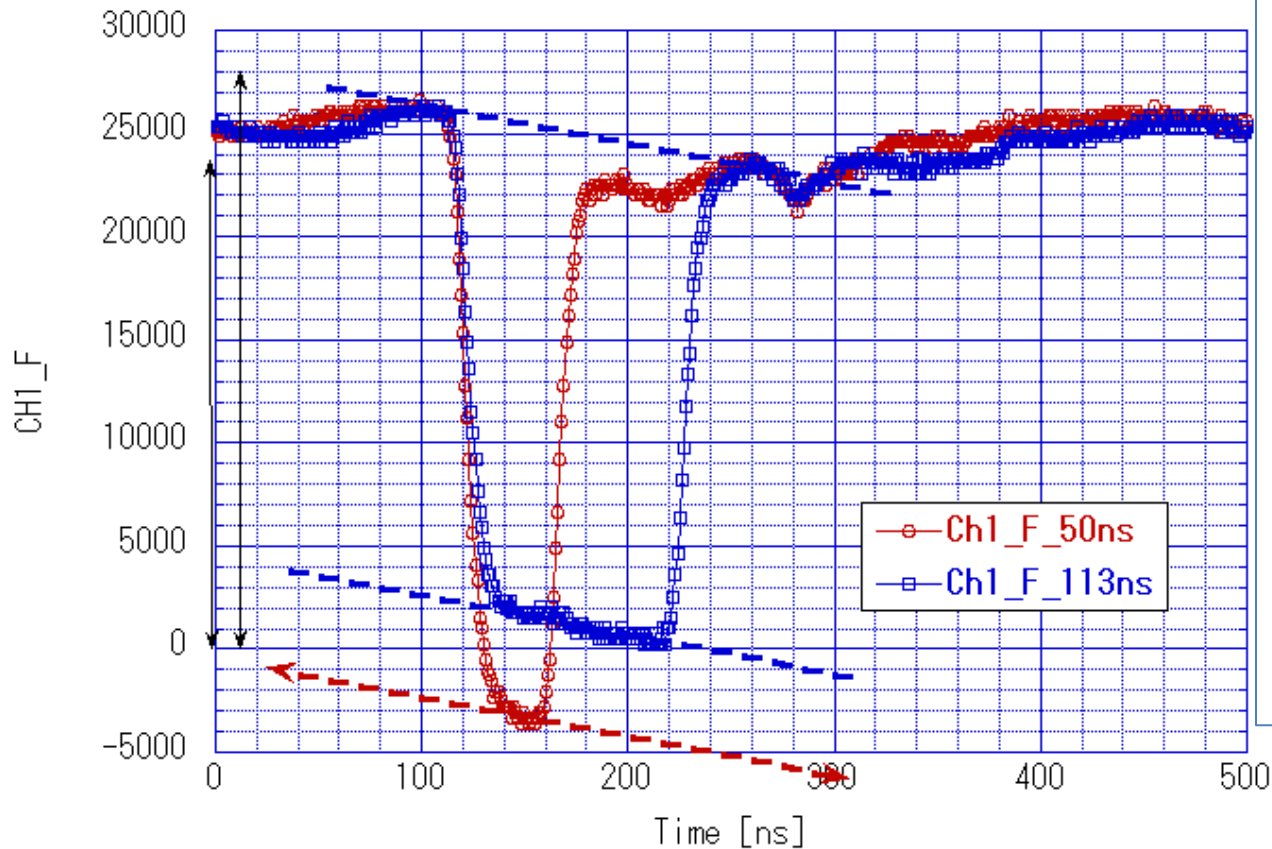
# ACC-IN pulse at hard limit

Limit at similar pulse heating temperature, but more precise comparison is needed.

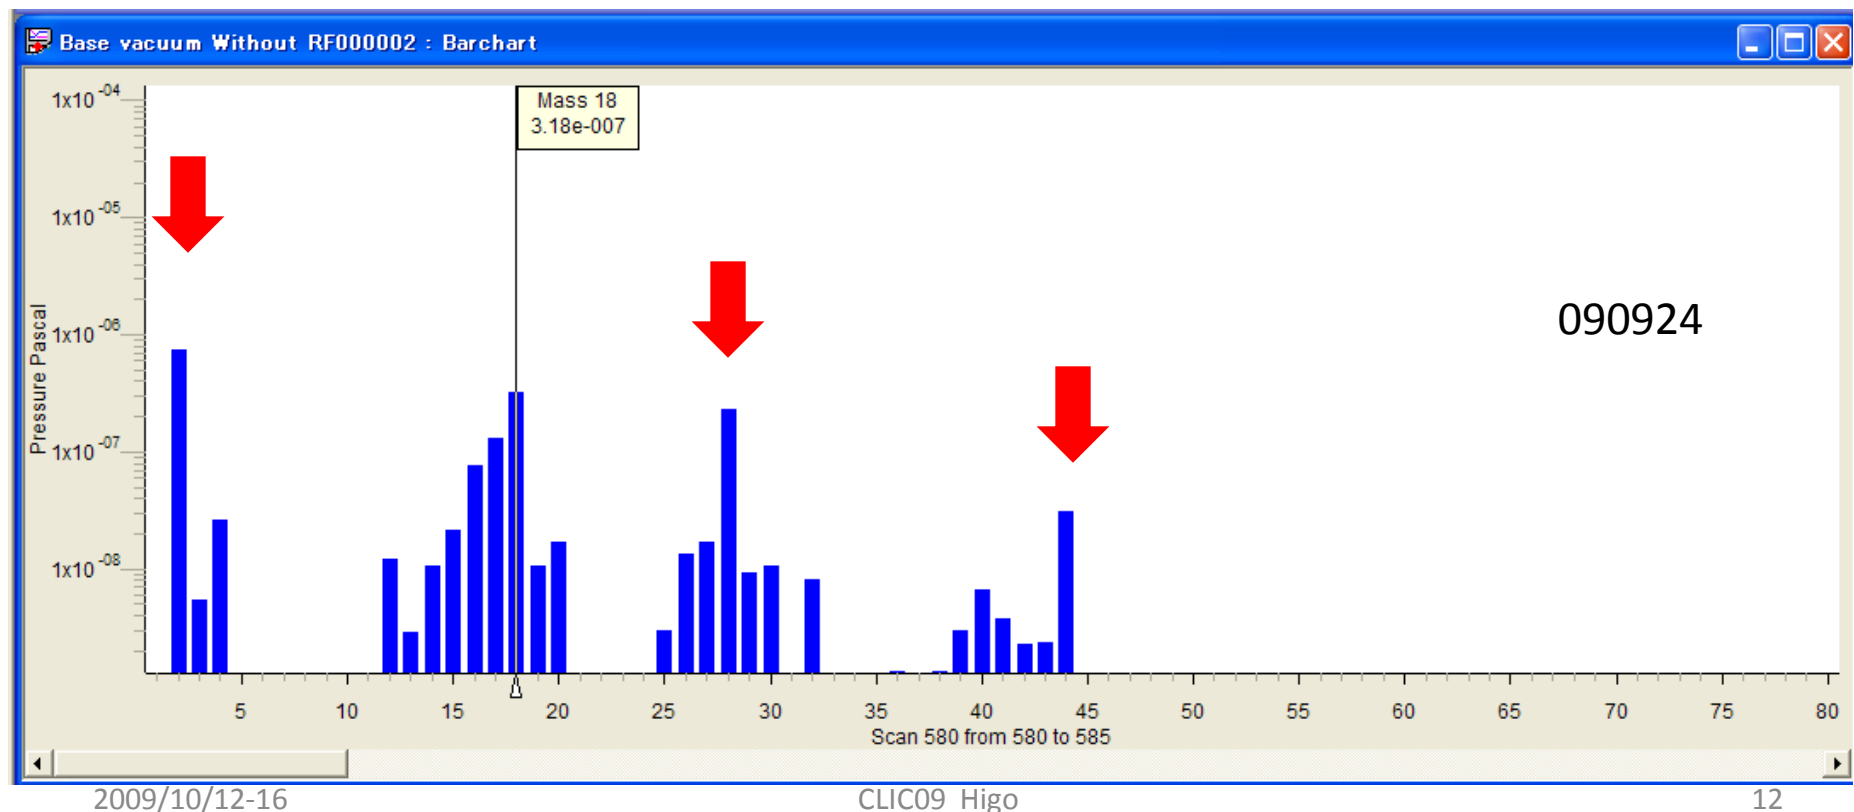
# First QMA observation with RF OFF. QMA- ACC Chamber valve opened.

Peak at M=2 (H<sub>2</sub>) largest. Water (18) becomes moderate. Others are M=28 (CO) and 44(CO<sub>2</sub>).

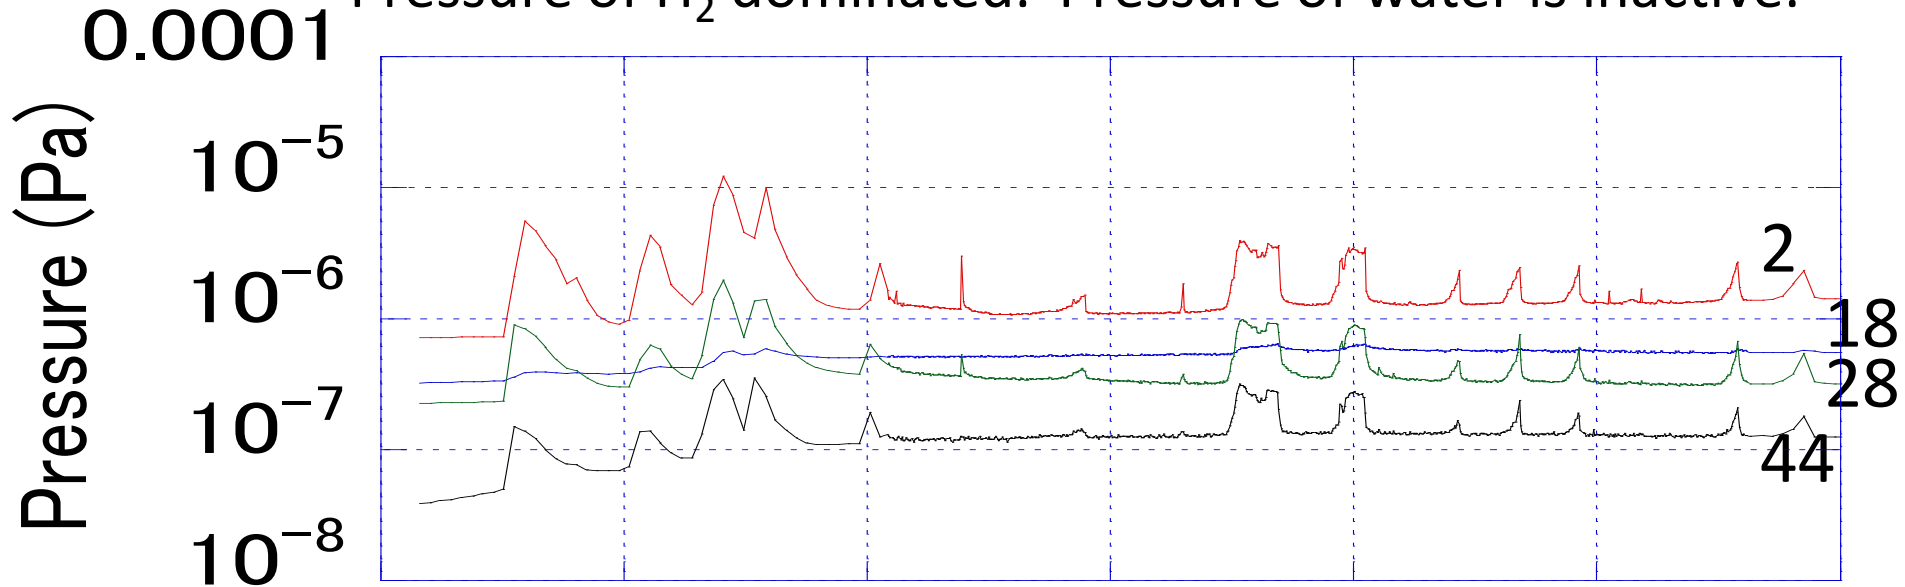
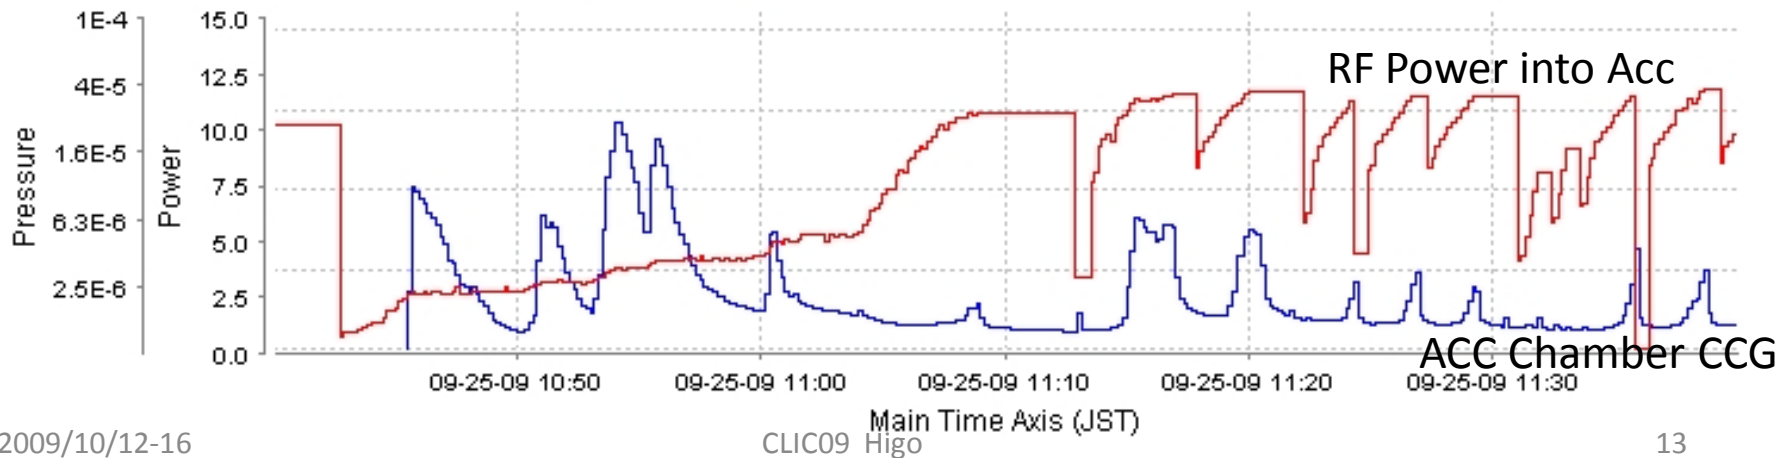
# QMS (1) :RF Power and gases

Pressure of H<sub>2</sub> dominated. Pressure of water is inactive.

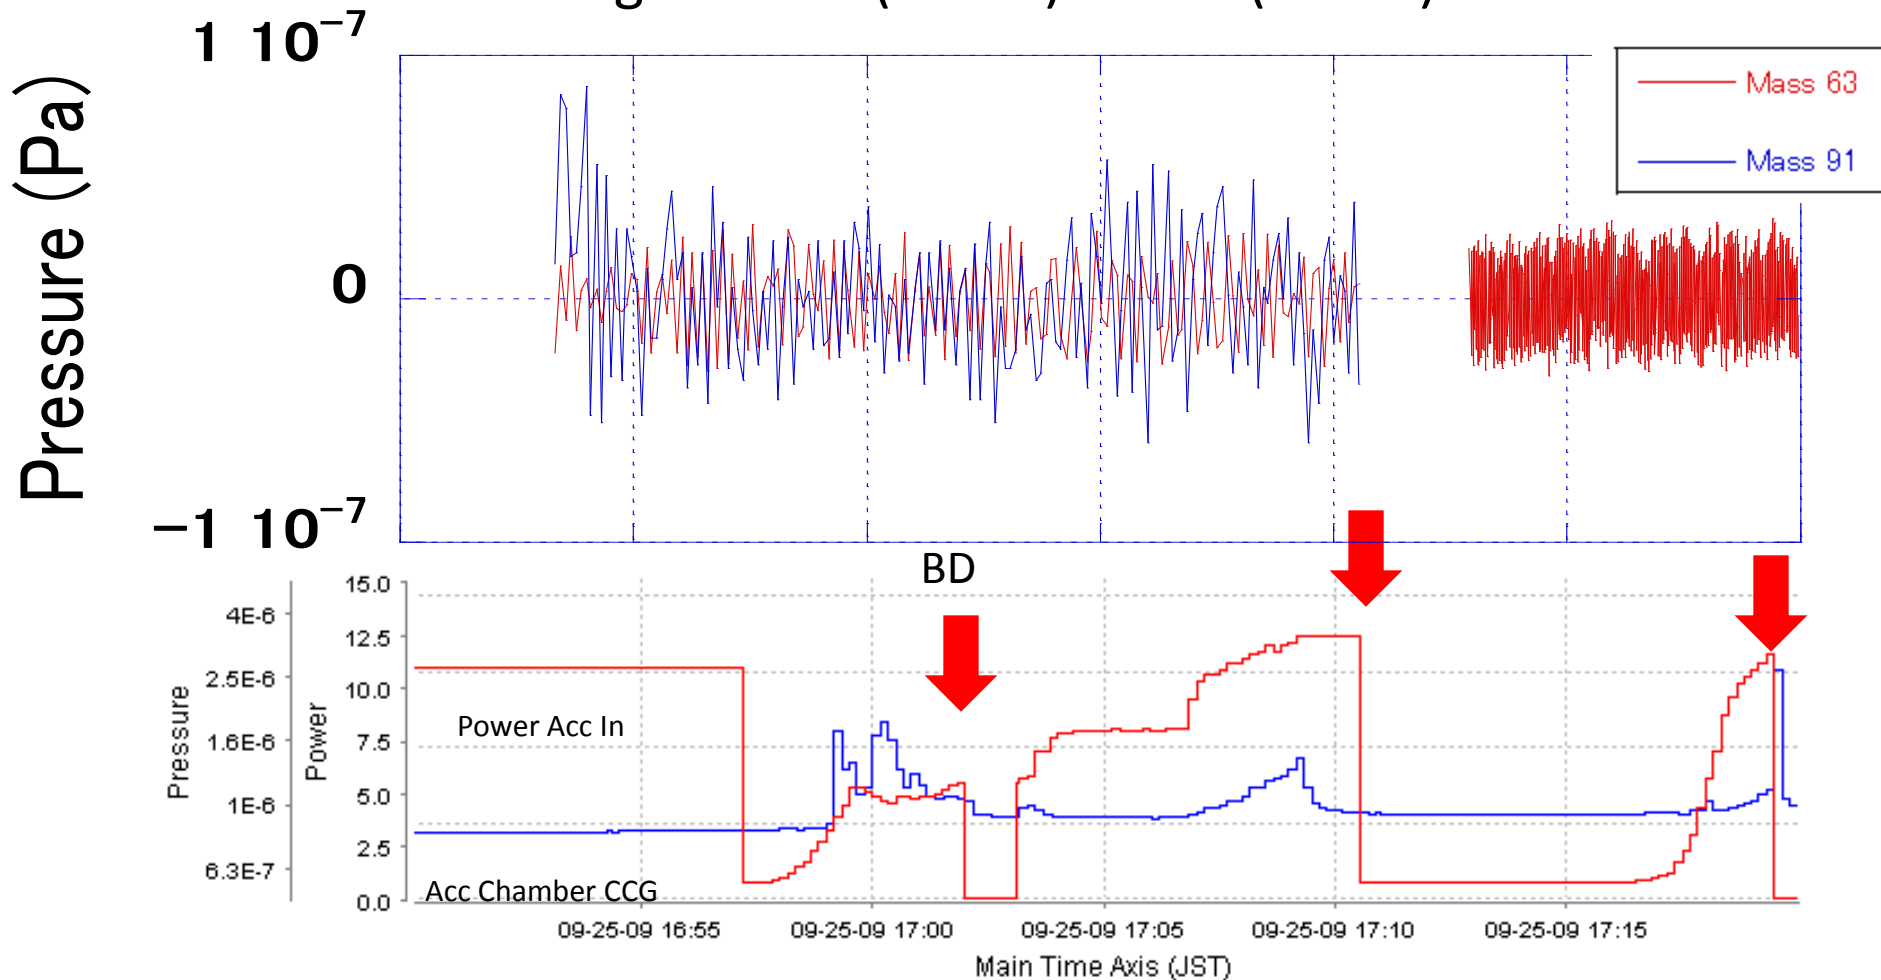
# QMS (2): Cu and Zr

No signal of Cu(M=63) nor Zr (M=89) .

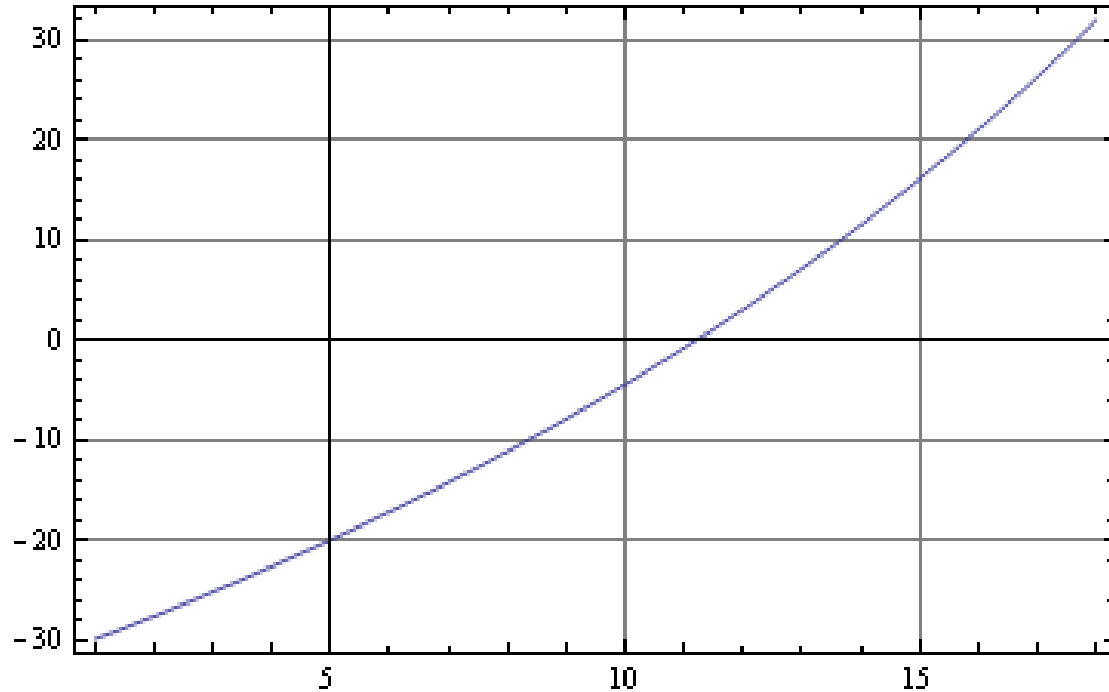
# T18 structure Function $F[z]$

Use time difference  $R_s(\text{rise}) - T_r(\text{fall})$  to calculate BD position.  
Function  $F(z)$  is calculated from design  $v_g(z)$ .

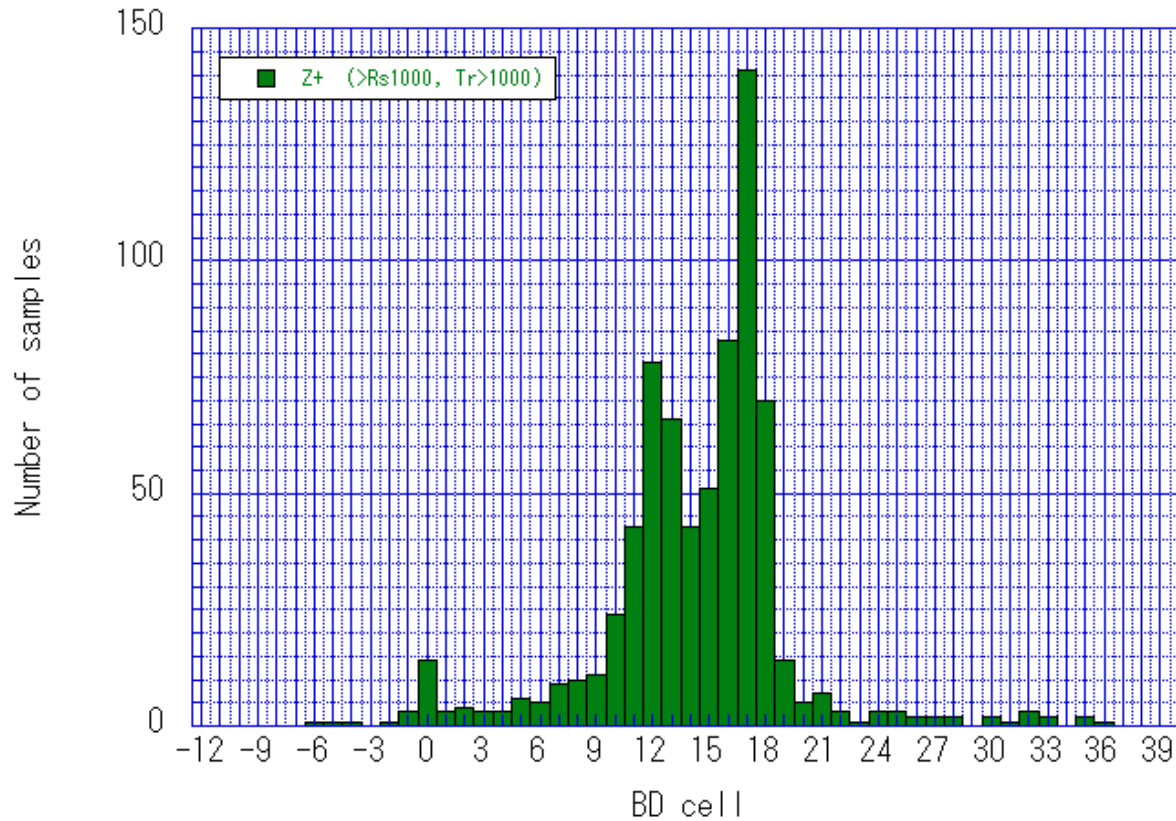
## Quad #5 BD cell distribution

DPO Run4  
Rs>1000, Tr>1000

713 events were analyzed out of 1919 INTLK.

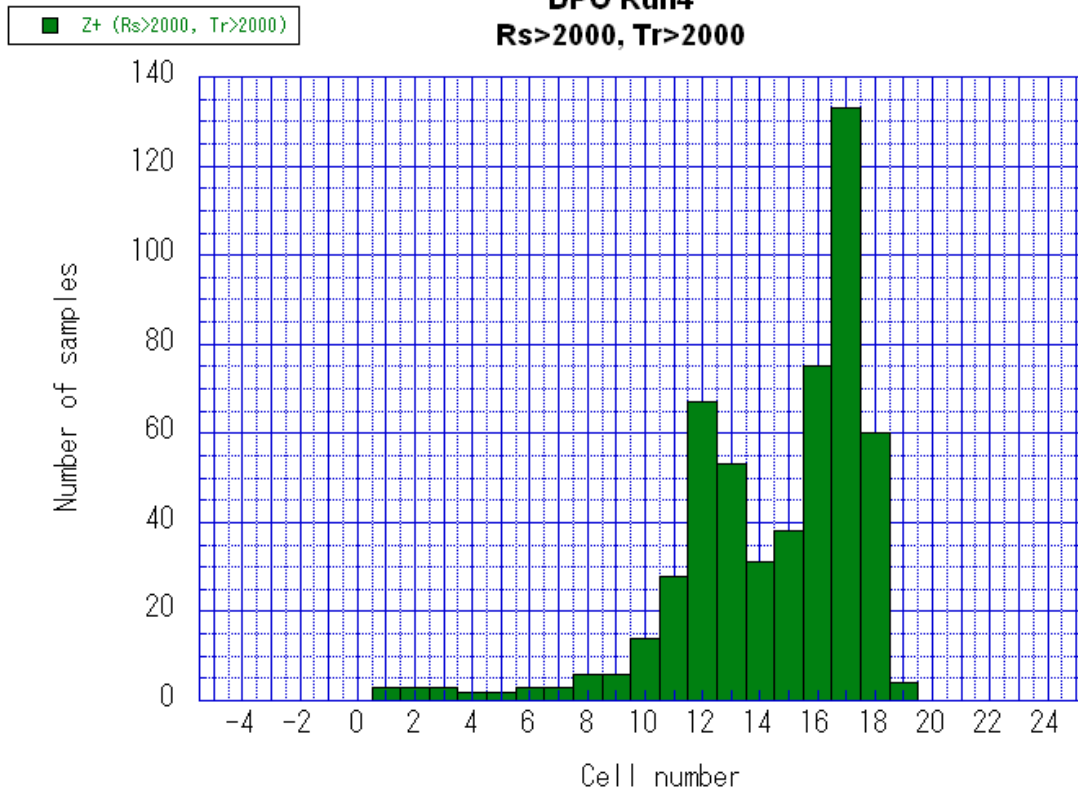
Quad #5 BD cell distribution  
DPO Run4  
Rs>2000, Tr>2000

Mostly  
downstream half.

Simply increasing  
toward output  
end.

Indication of BD  
following some  
field gradient.

534 events were analyzed out of 1919 INTLK.

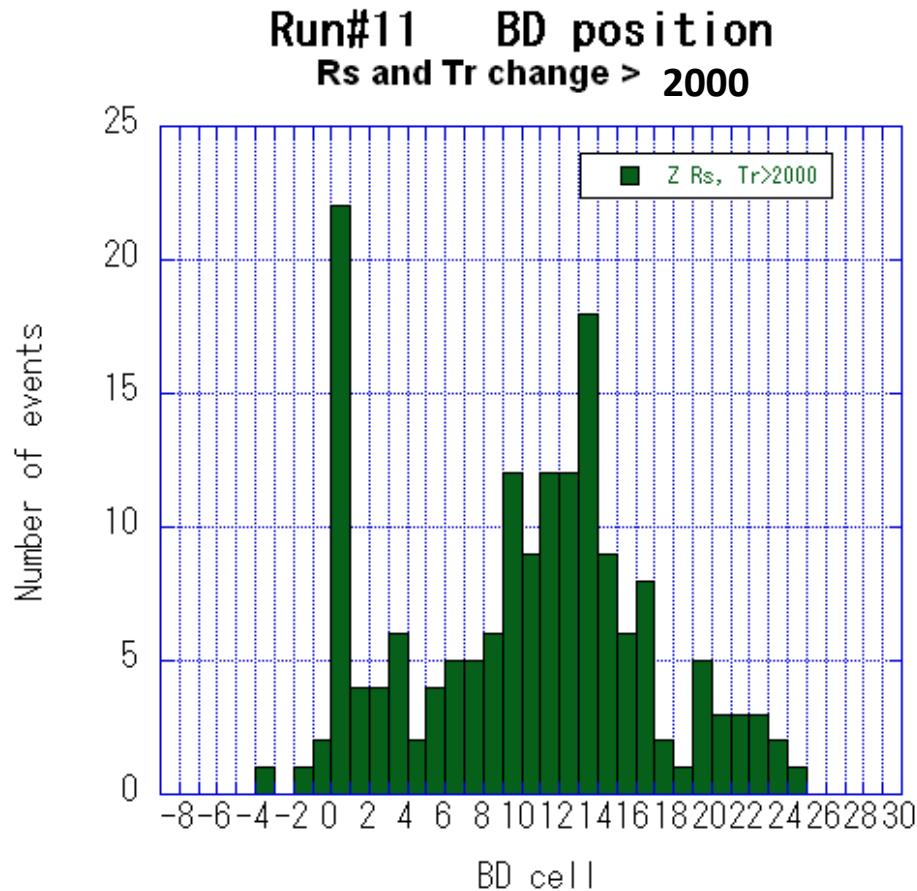
# BD position of run11 113ns, MW

It is evident that there is difference than 50ns.

Not increasing toward output side.

Need to check the peak at cell#0.

Need to check those outside structure cell region.

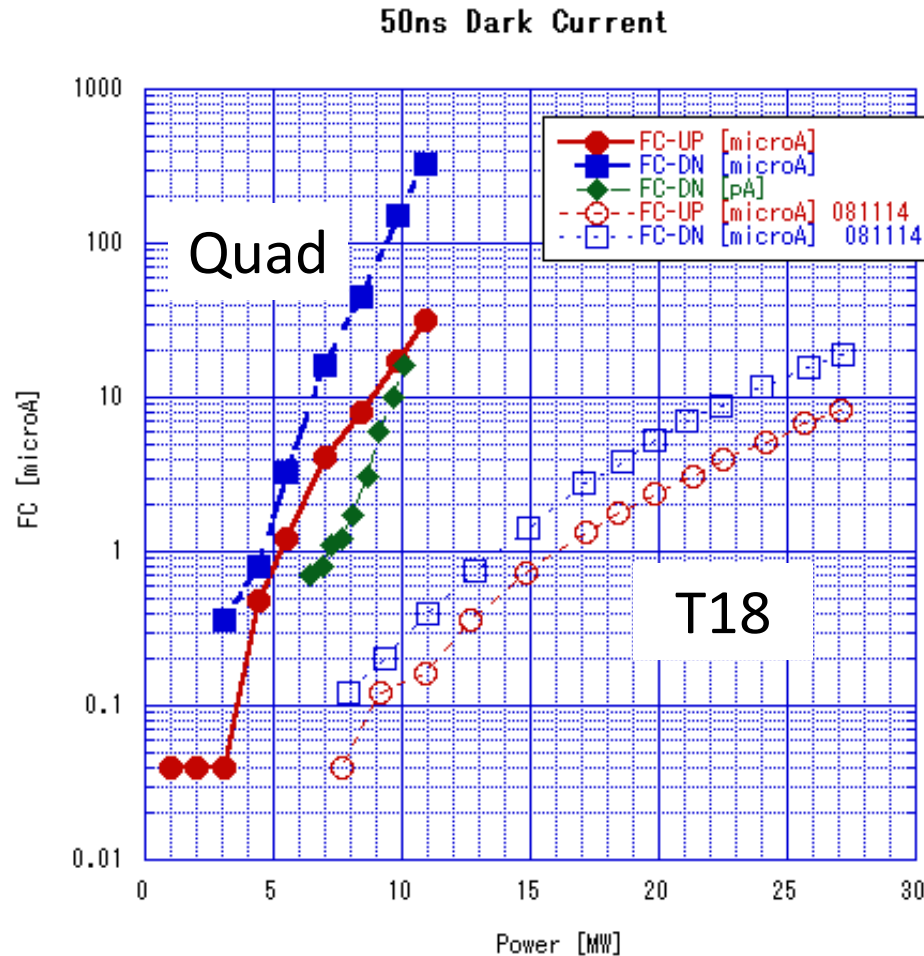
# Quad dark current much larger than T18

(Note: Power is just the value in the control program panel. Read 12MW as 19MW, though relative comparison between quad and T18\_disk is OK without this.)

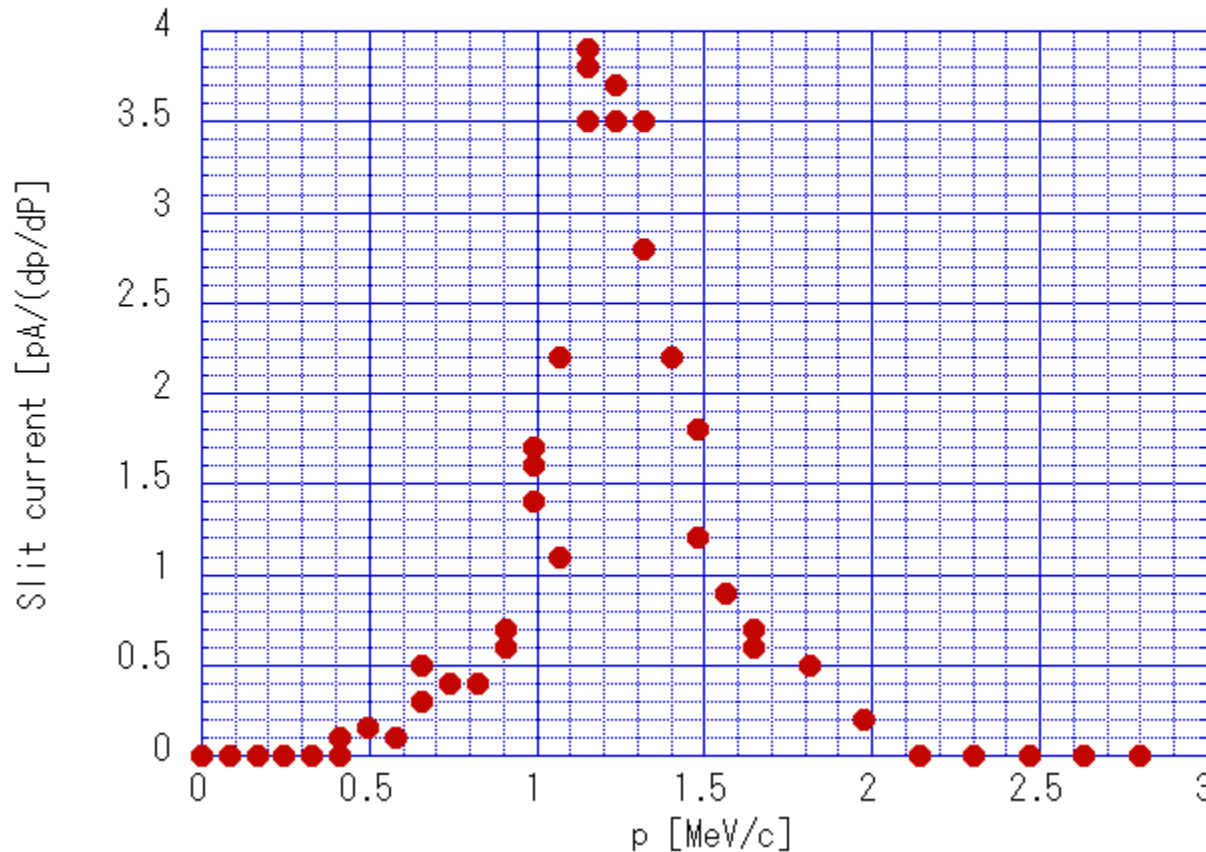
Quad #5 Dark current spectrum  
50ns, 19MW

T18\_Disk  
Peaks at 8MeV/c  
and 4MeV/c with  
108MV/m

Present quad  
Peak at 1.2MeV/c  
with 19MW →  
59MV/m

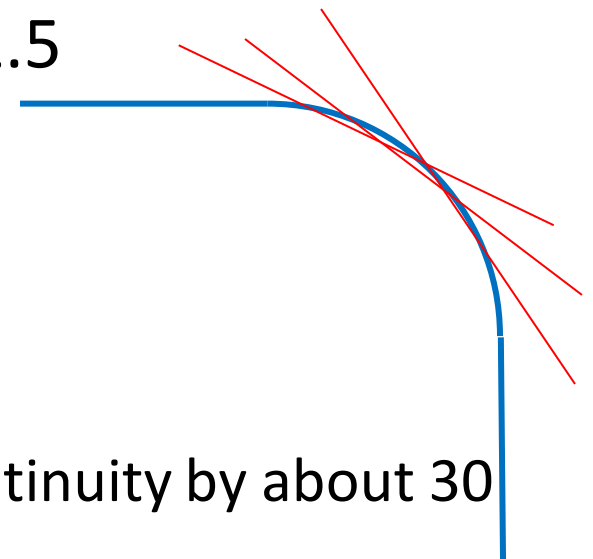
## Field enhancement due to round chamfer

- Simulation of field enhancement
  - 1.4 ~ 1.6 at radius
  - with  $\text{gap} < \text{radius}/5$ ,  $\text{step} < \text{radius}/2.5$
- Only a few tool passes
  - to shape 50 micron radius
  - with radius tool of 2mm
    - If three passed  $\rightarrow$  tangential discontinuity by about 30 degree
    - Can be relaxed by such as EP in future

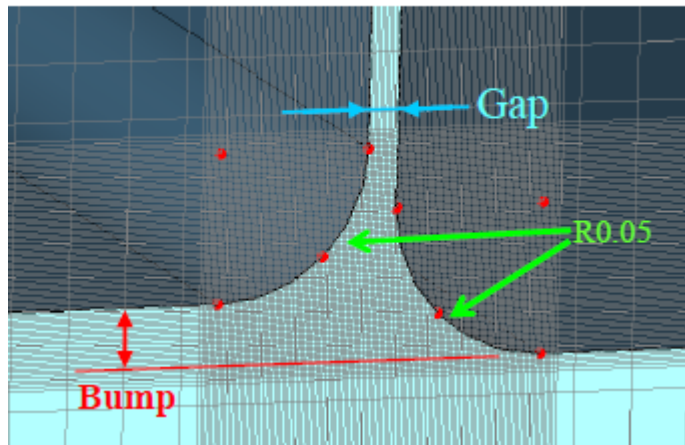
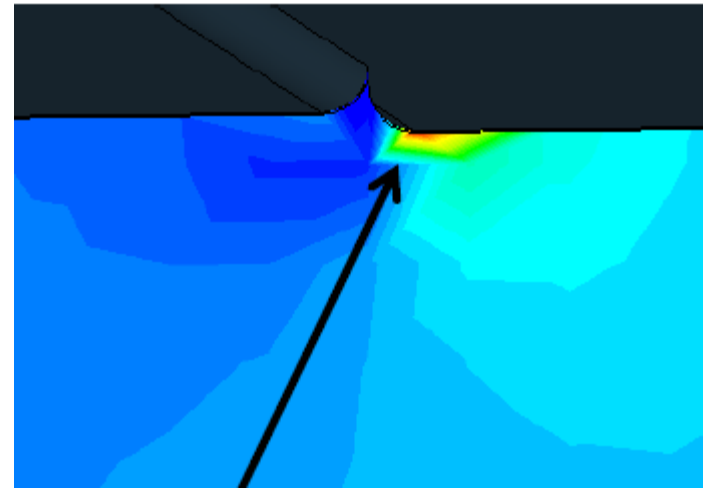
# Electric field enhancement in a shallow channel with round chamfer

Calculation done by T. Abe by CST MS. Waveguide field.

Gap (micron)	Bump (micron)	$E_{max} / E_{nominal}$
0	0	1.39
0	20	1.57
10	20	1.58

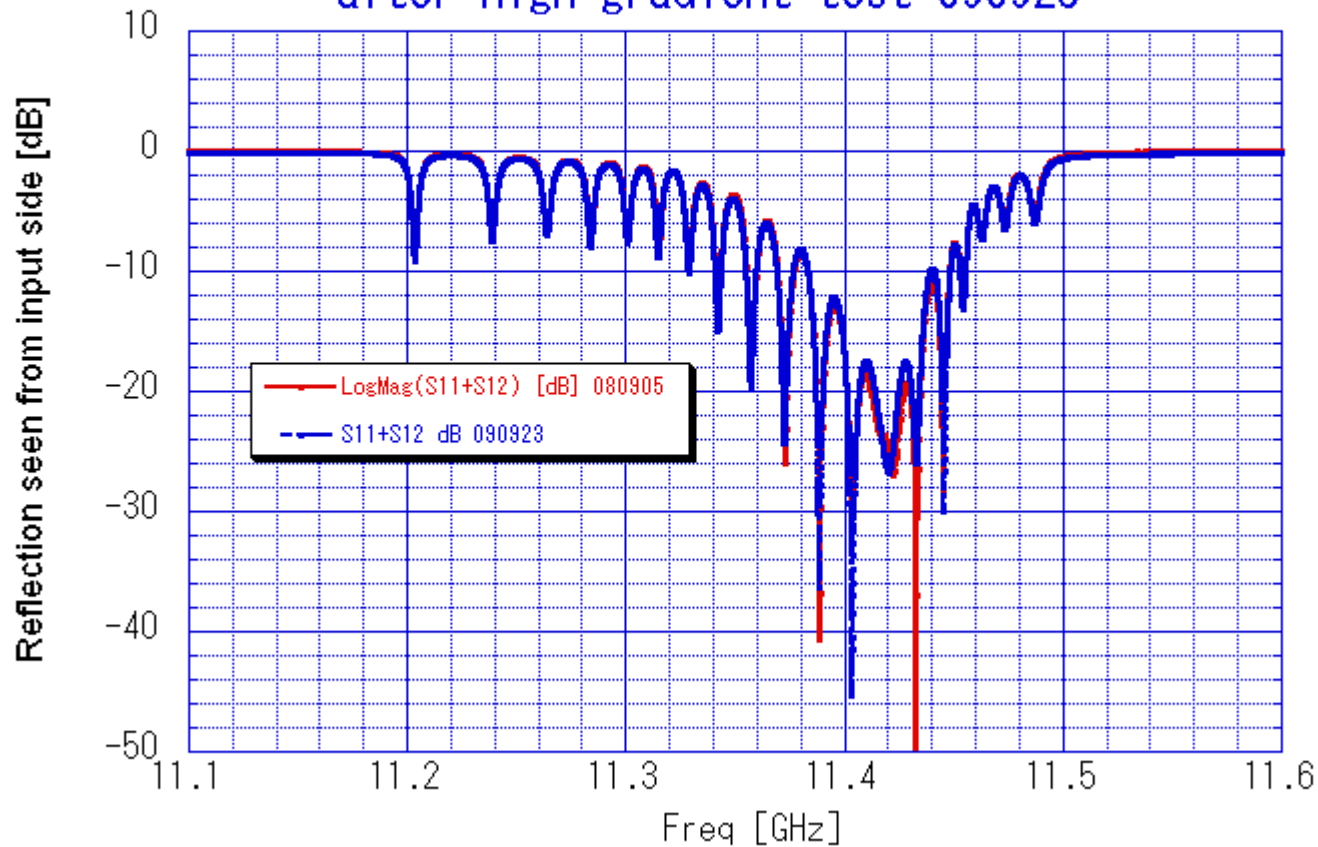
# Input match not changed

T18\_VG2.4\_Disk\_#2 Input coupler matching  
before installation 080905  
after high gradient test 090923

- RF evaluated after high gradient test.
  - Input matching was kept.
  - Output matching changed by  $\Gamma=0.05$  level.
  - Average frequency increased by 1.1MHz.
  - Field ripple  $\pm 4.4\%$  near output end.
- Some change in RF performance was observed.
  - Need to compare carefully with SLAC data.

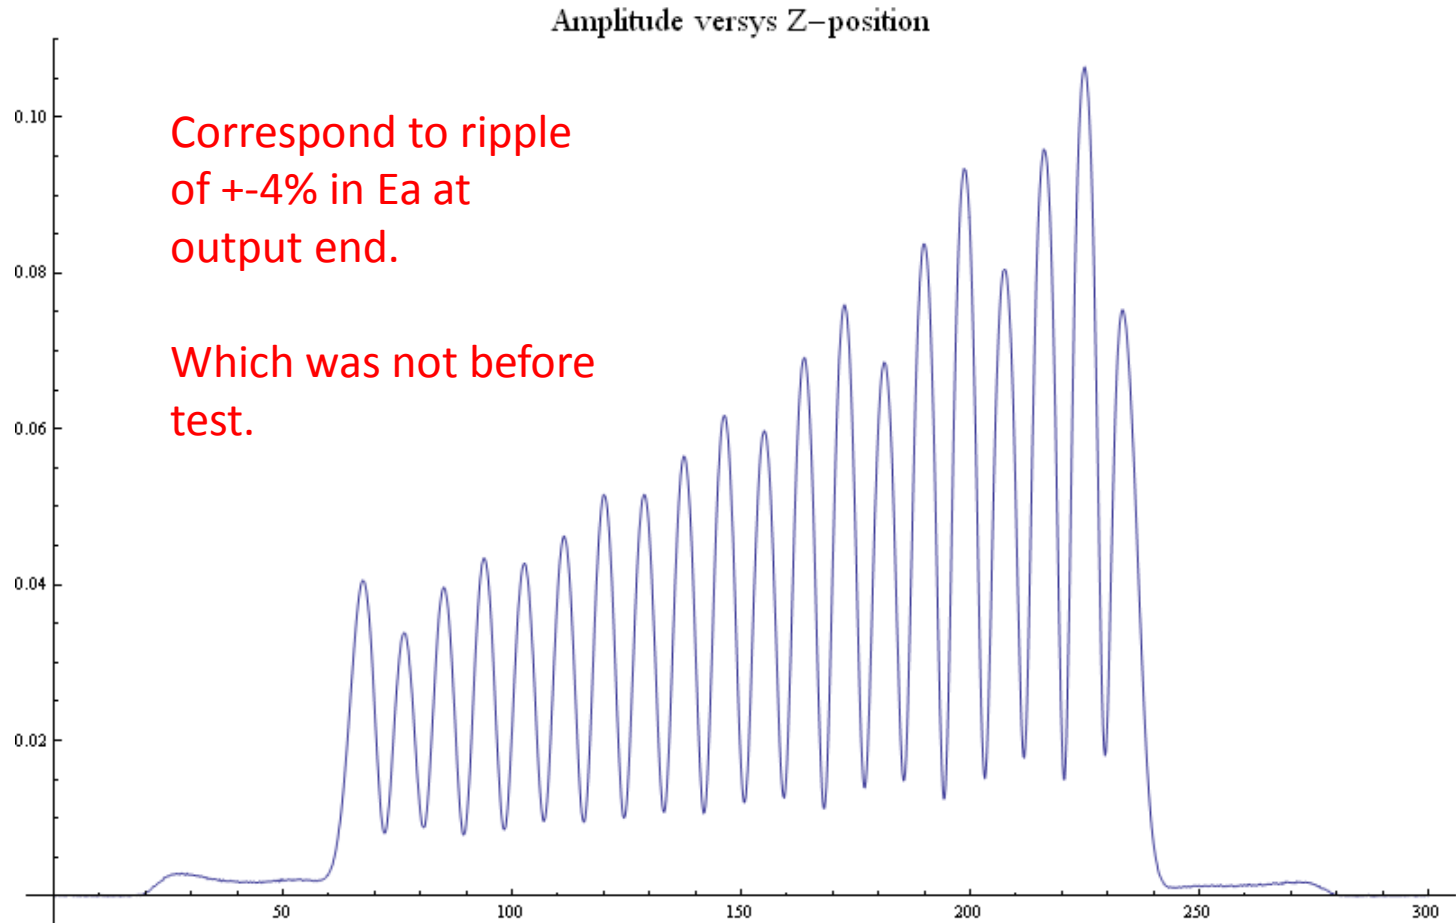
# Bead pull amplitude plot 11422MHz

Correspond to ripple  
of  $\pm 4\%$  in  $E_a$  at  
output end.

Which was not before  
test.

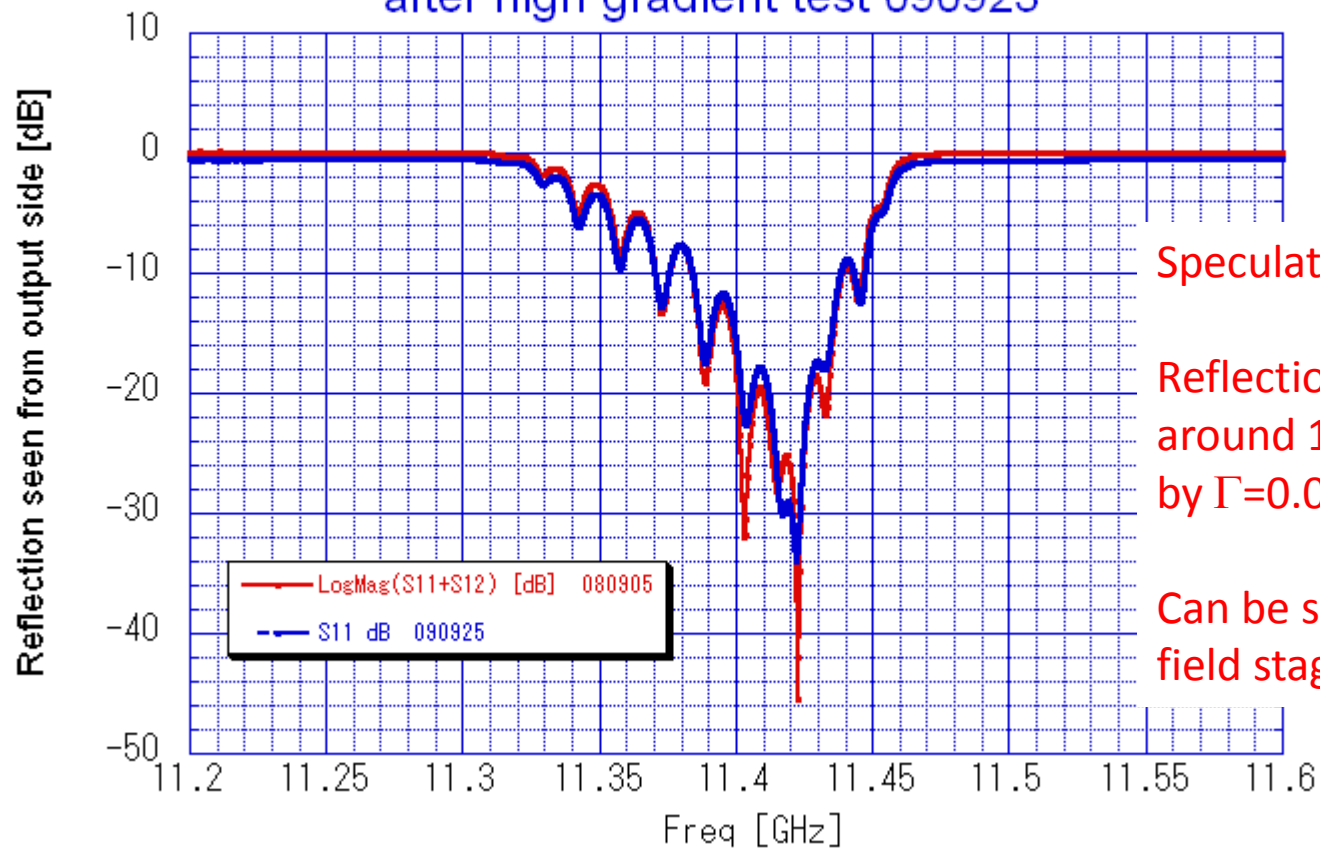
# Output match some change

T18\_VG2.4\_Disk\_#2 Output coupler matching

Reflection changed  
around 11424MHz  
by  $\Gamma=0.05$  level??

Can be source of  
field staggering

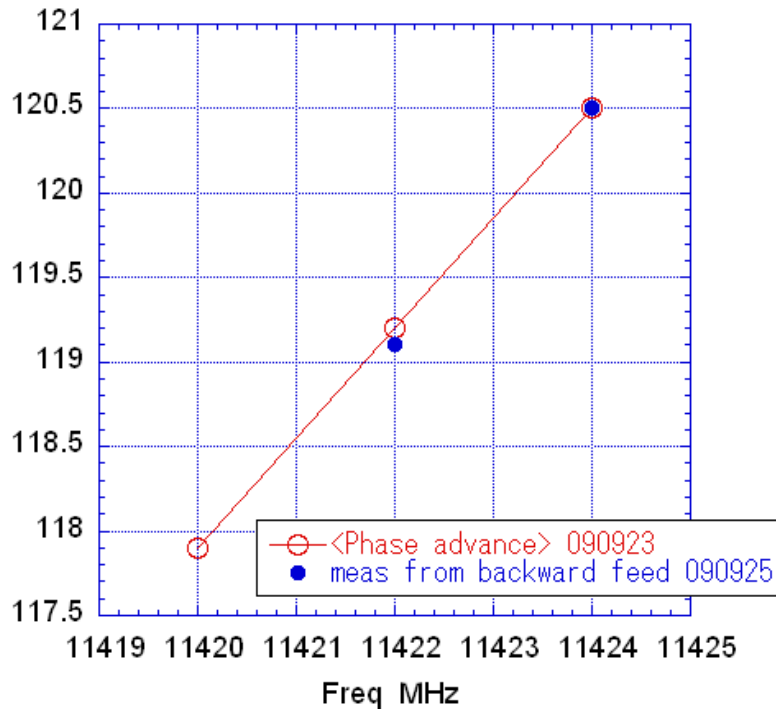
# Phase advance per cell

at 22.7degC in Nitrogen

11423.2MHz  $\rightarrow$  120deg/cell

delF 22.7  $\rightarrow$  30C -1.38MHz

delF N2  $\rightarrow$  VAC +3.12

delF string  $\rightarrow$  no string +0.2MHz

Total delF = 1.94MHz

120deg/cell at 11425.1MHz

Changed by 1.1MHz through  
high gradient test!?!?

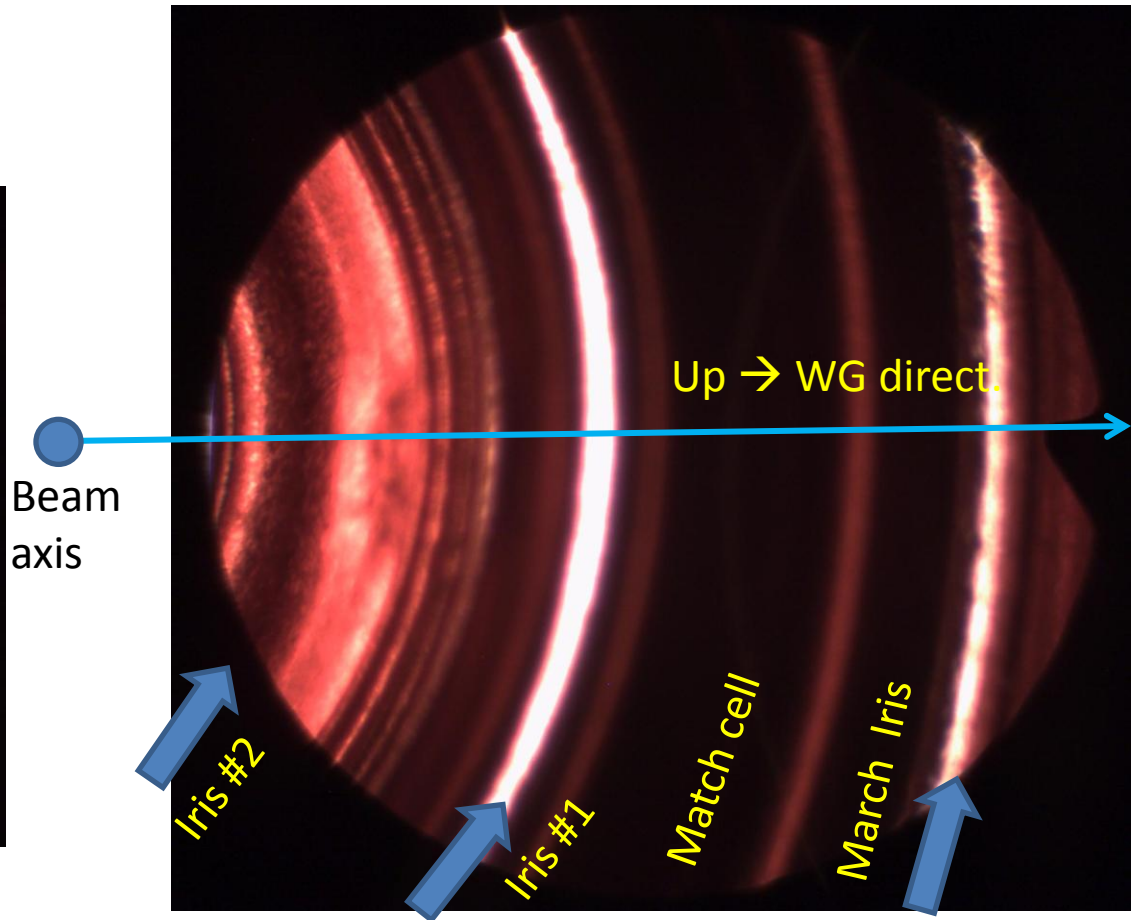
Insertion 98.0mm for observing Iris #2.  
This is the best we can now, only the  
forward iris at an enough distance.

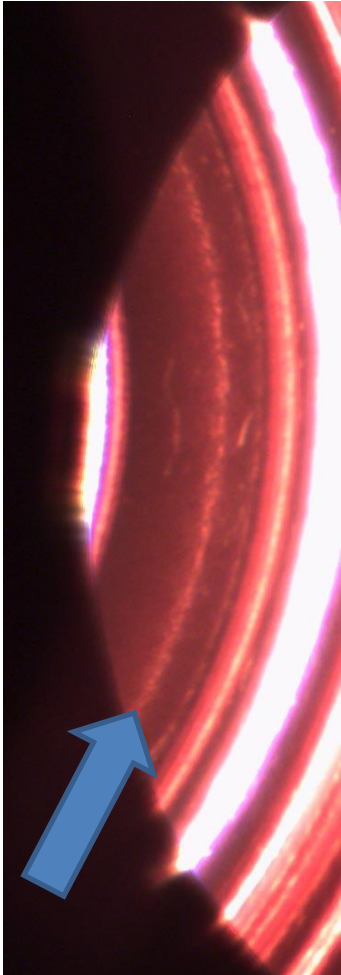
Insertion 82.7mm  
Iris #1 at match cell

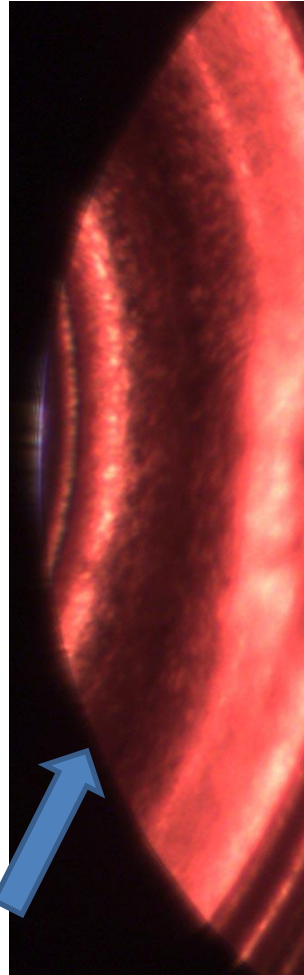
Insertion 98.0mm  
Iris #2 at first  
regular cell

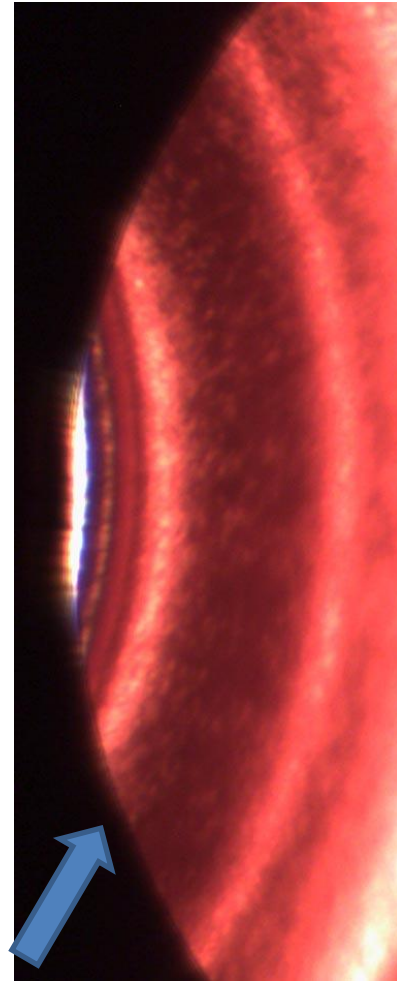
161.9mm Iris #9
