# Nextef results

CLIC09, Oct. 12-16

T. Higo (KEK)

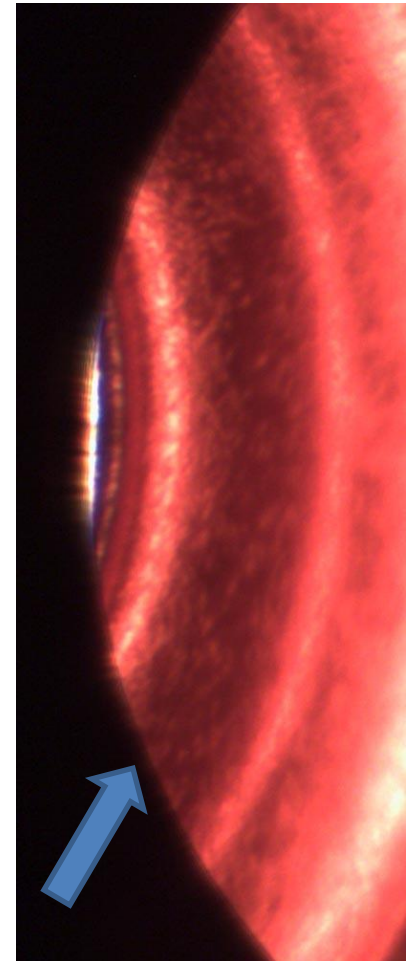
170.9mm Iris #10

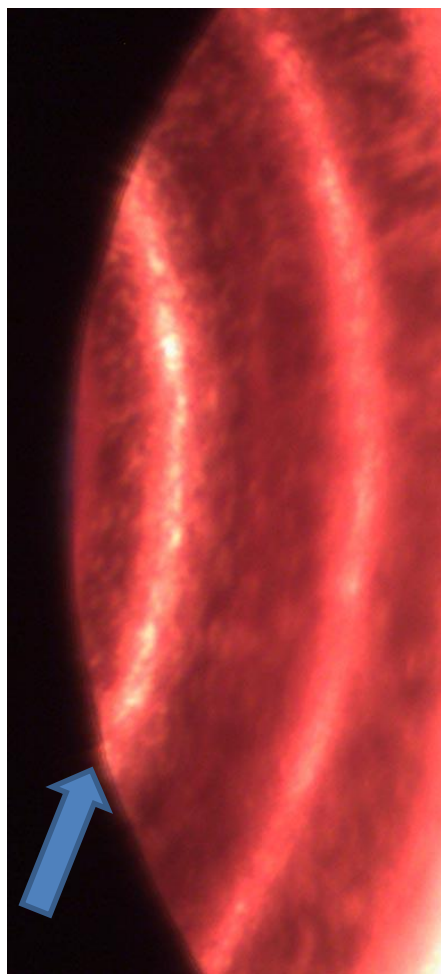
243.2mm Iris #18  
Upside iris of last regular  
cell

- No significant variation was observed
  - Comparing input to output but
- Need to inspect with better resolution
  - Change to straight bore scope?
  - Adjust focal plane?
  - Should be improved

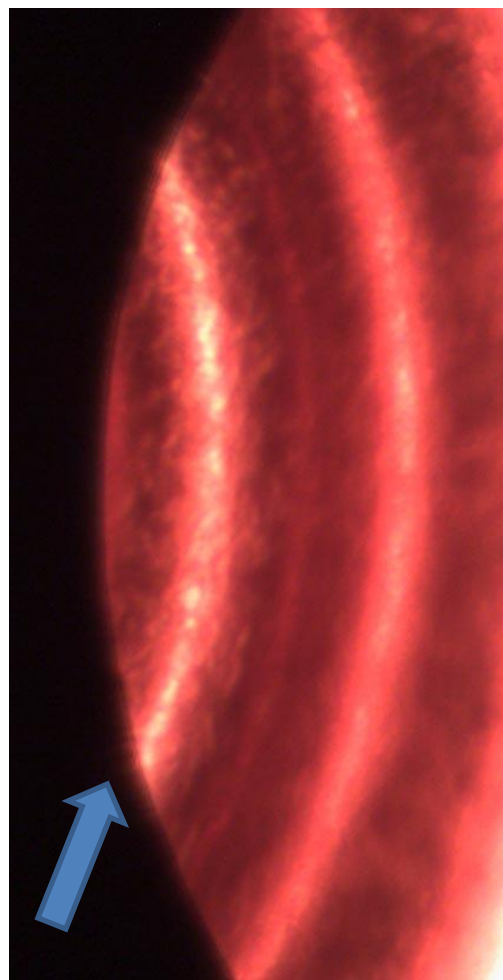
252.2mm Iris #19  
Down side iris of last  
regular cell

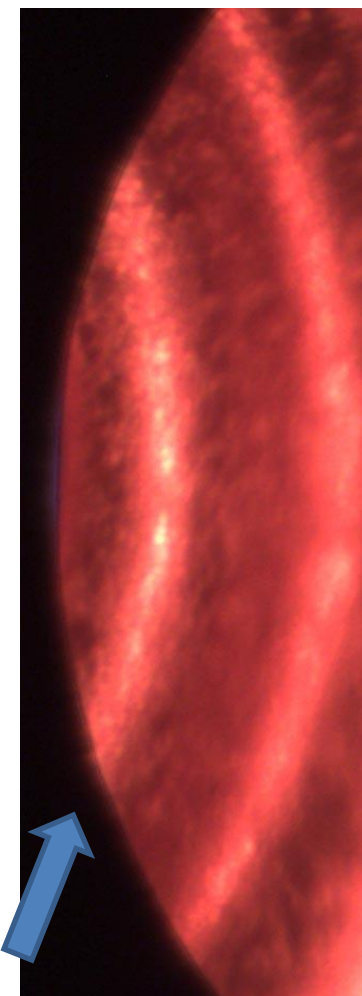
261.3mm  
Last regular cell iris #20
