Surface observation of Scanning Field Emission Microscope and Cu/Mo, Cu/S.S Clad-material Cell Development for High Gradient X-band Structure

XB-10 Workshop

30 November 2010

KEK

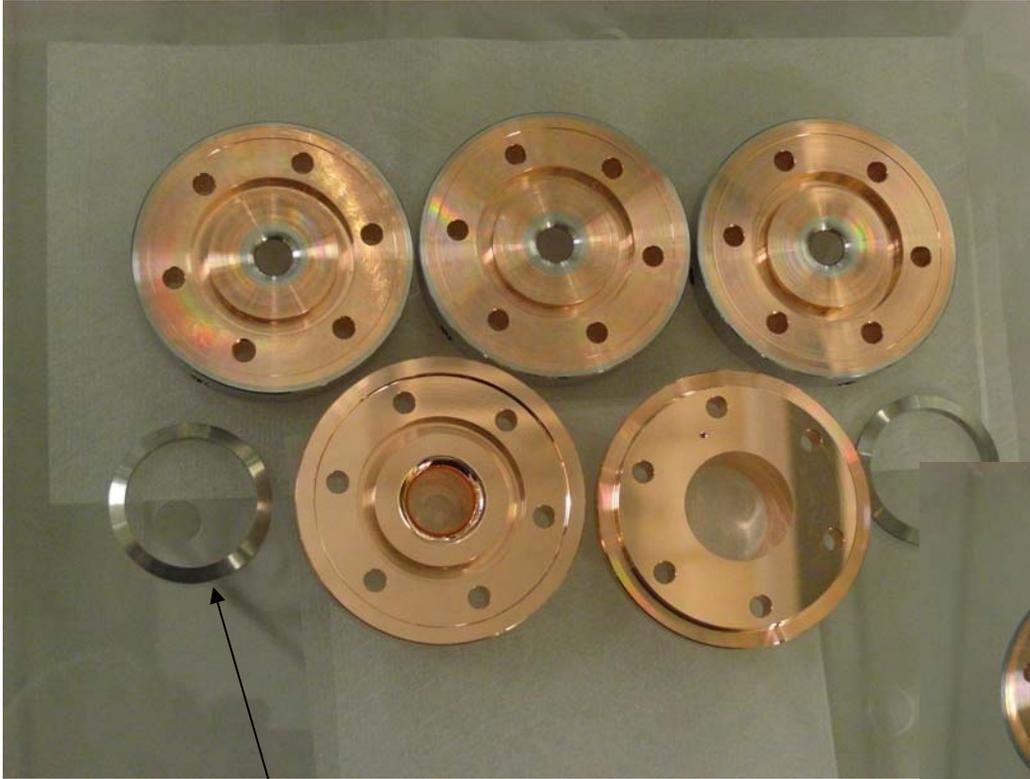
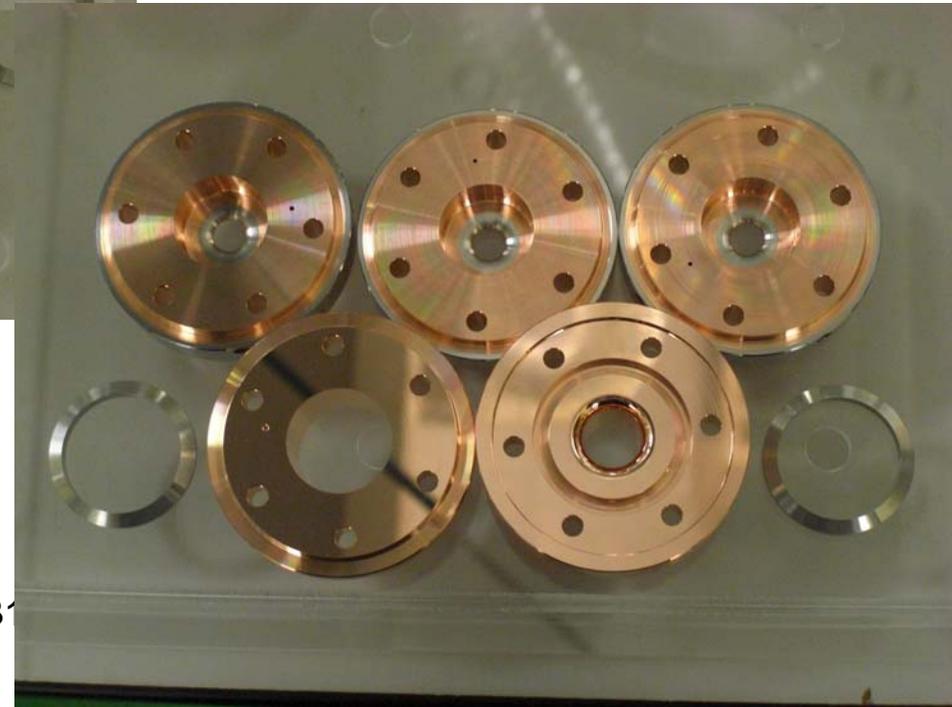
1C-SW-A3.75-T2.60-Cu/SUS-clamped

Ag coated SUS gaskets

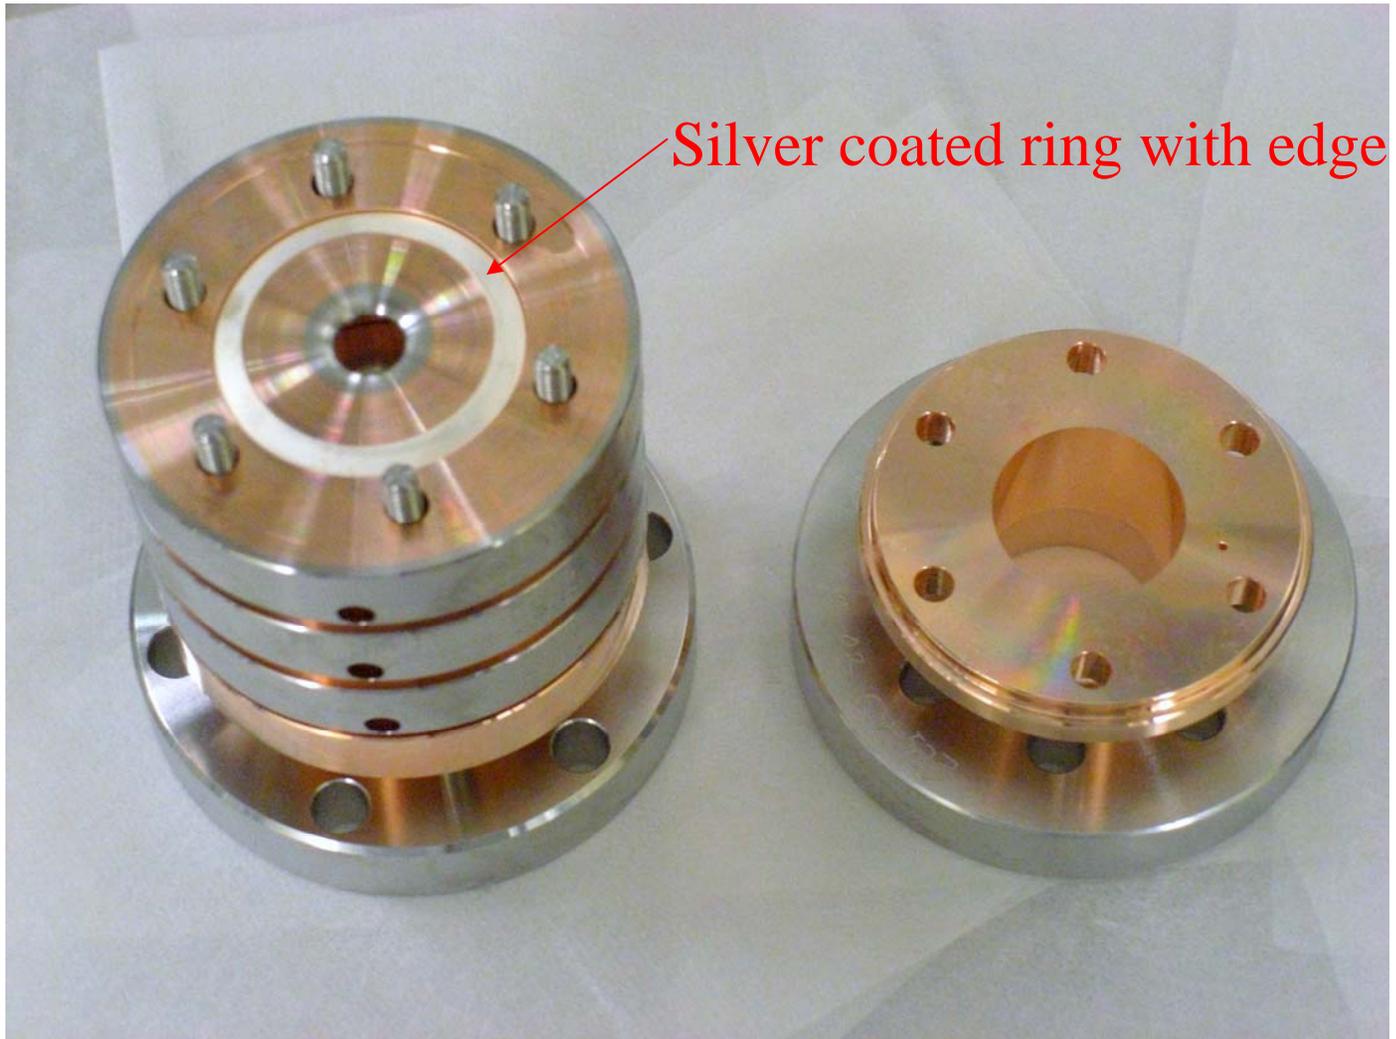
Assembly test

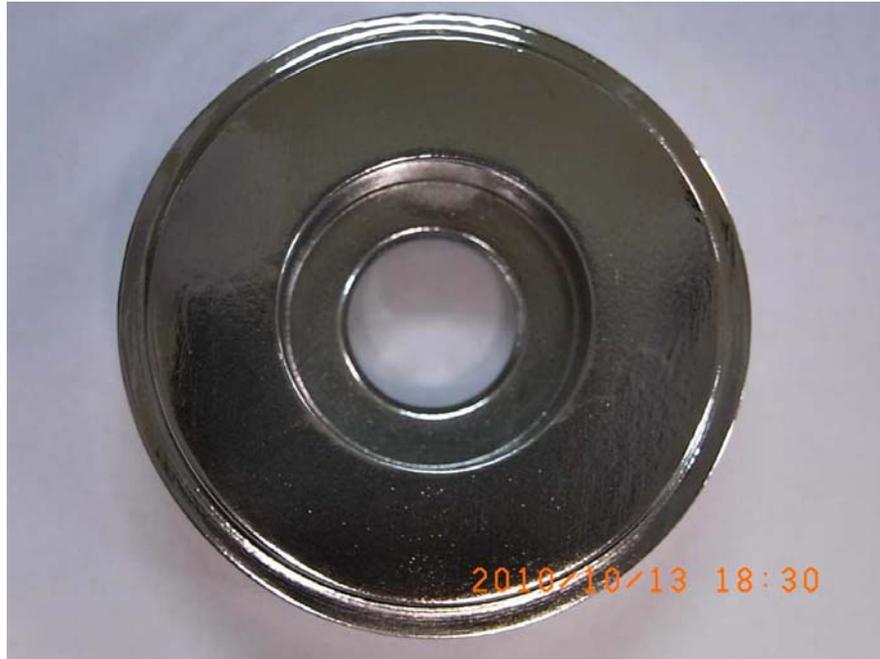
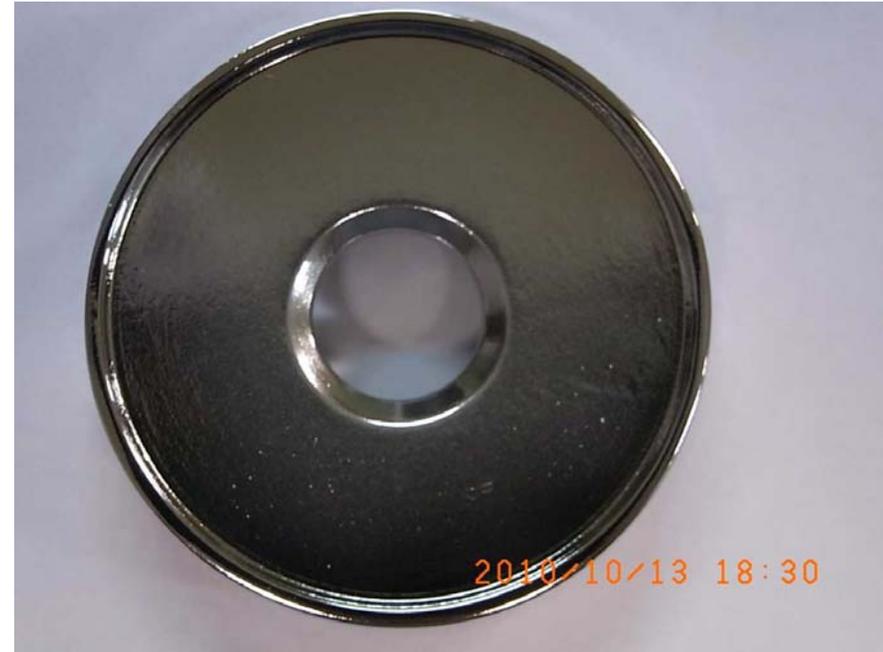
Electro Polishing of Mo

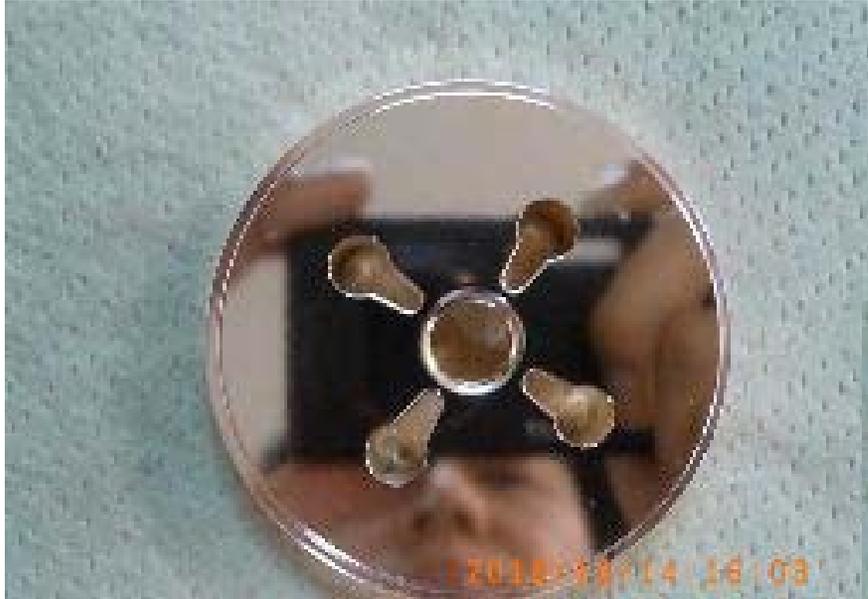
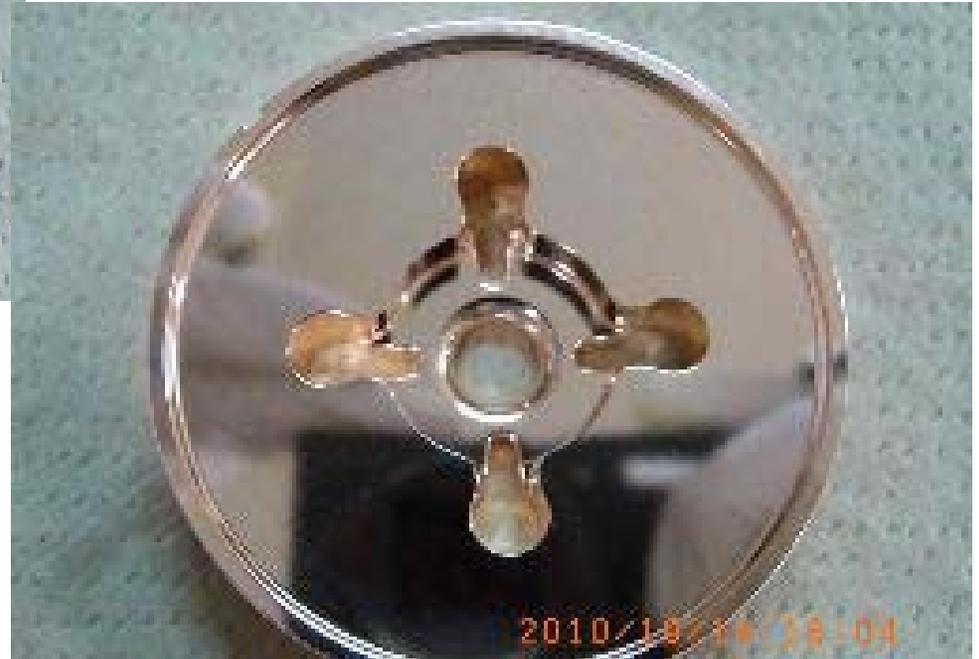
Electro Polishing of Copper

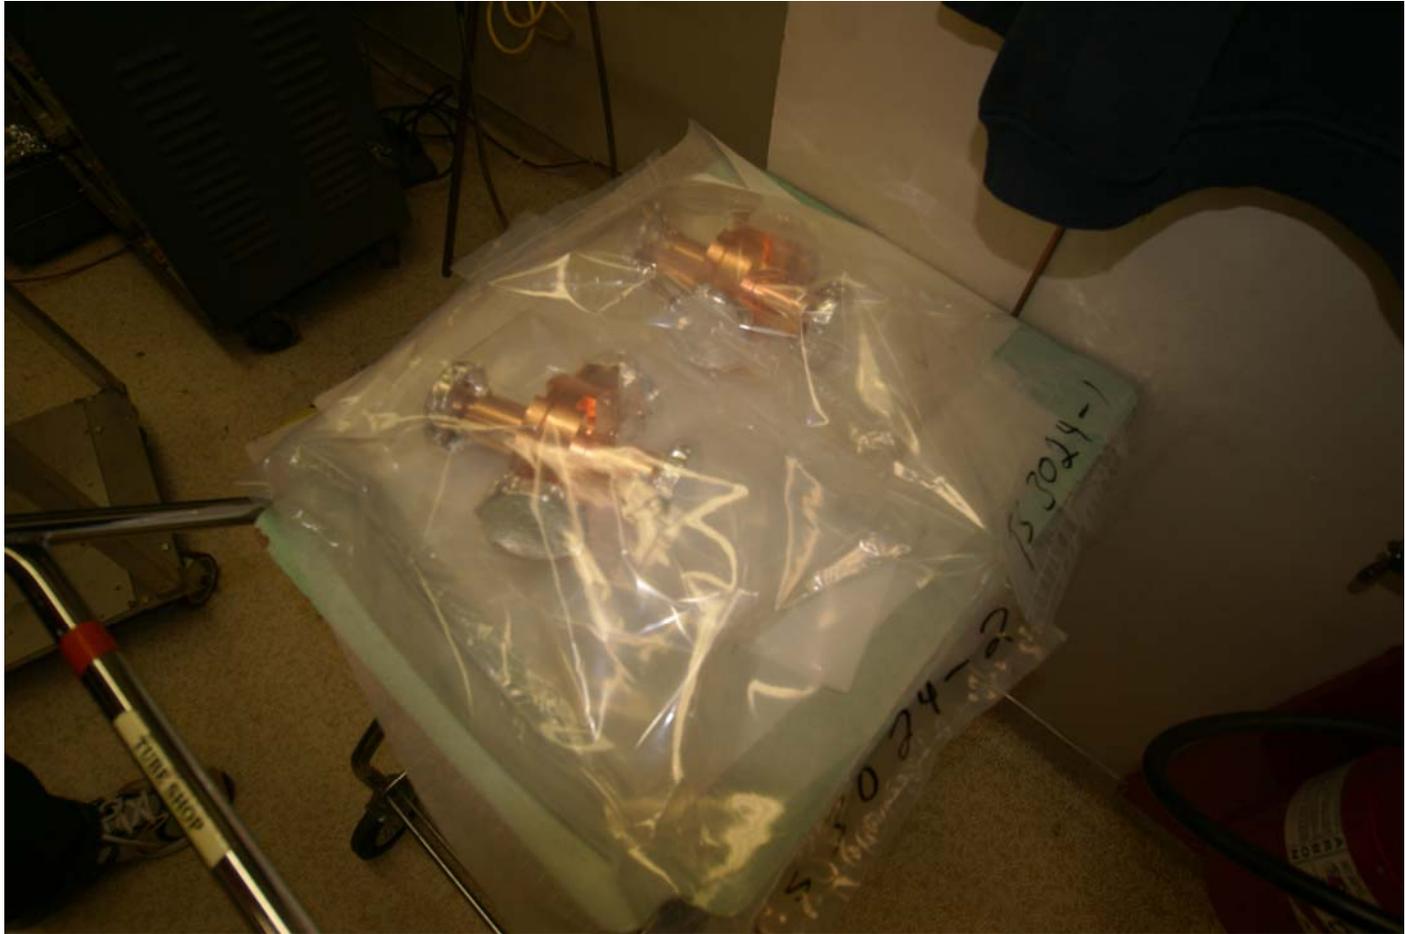
A new choke cavity fabrication

November 24 at SLAC

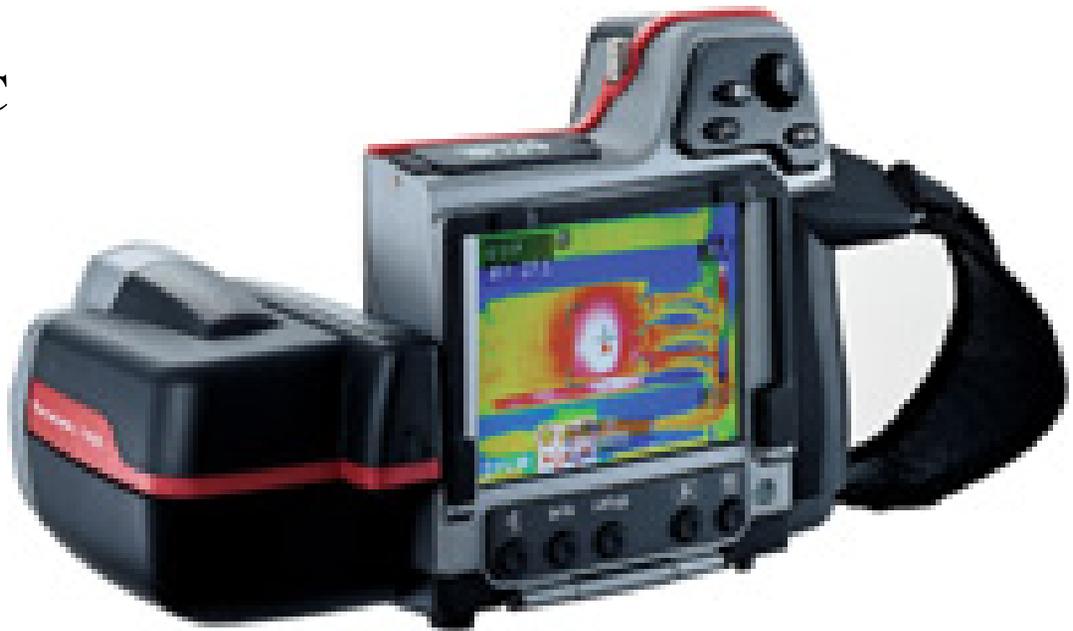
Thermo Vision CPA-T340 (Chino Co. Ltd.)

Measured temp.: 0~350 degC

Resolution: 0.08 deg. C

Frame-rate: 60 Hz

Measured area: 30x30mm
