SPRING-8 蓄積リング架台変形の原因と床の長期変動 MAJOR CAUSES OF GIRDER DEFORMATION OF SPRING-8 STORAGE RING AND LONG-TERM VARIATION OF TUNNEL FLOOR

C. Zhang^{A)}, M. Hasagawa^{B)}, T. Shinomoto^{B)}, H. Yamamoto^{B)}

^{A)} Japan Synchrotron Radiation Research Institute

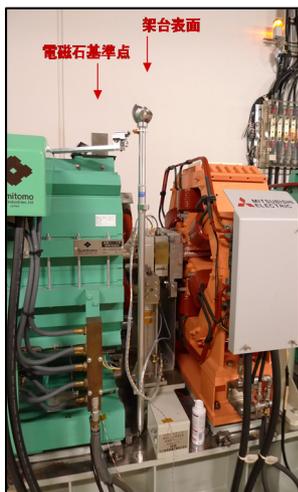
If zooming in the linearity errors of the magnets on common girders, it can be seen that the magnets were not displaced randomly but systematically. It seems that the girders have been bent in the vertical.

To check the deformations of girders we measured the shapes of girder surface with the laser tracker in 2013. The heights of magnet fiducial points were measured in the meantime for comparison (fig.4).

Figure 4: Measure the shape of girder surface and the heights of magnets.
